MAIDEN ROCK PHOSPHATE DISTRICT RECLAMATION

**MAIDEN ROCK PHOSPHATE
 DISTRICT PHASE II**
 Beaverhead County, Montana

RECLAMATION ACTIVITIES

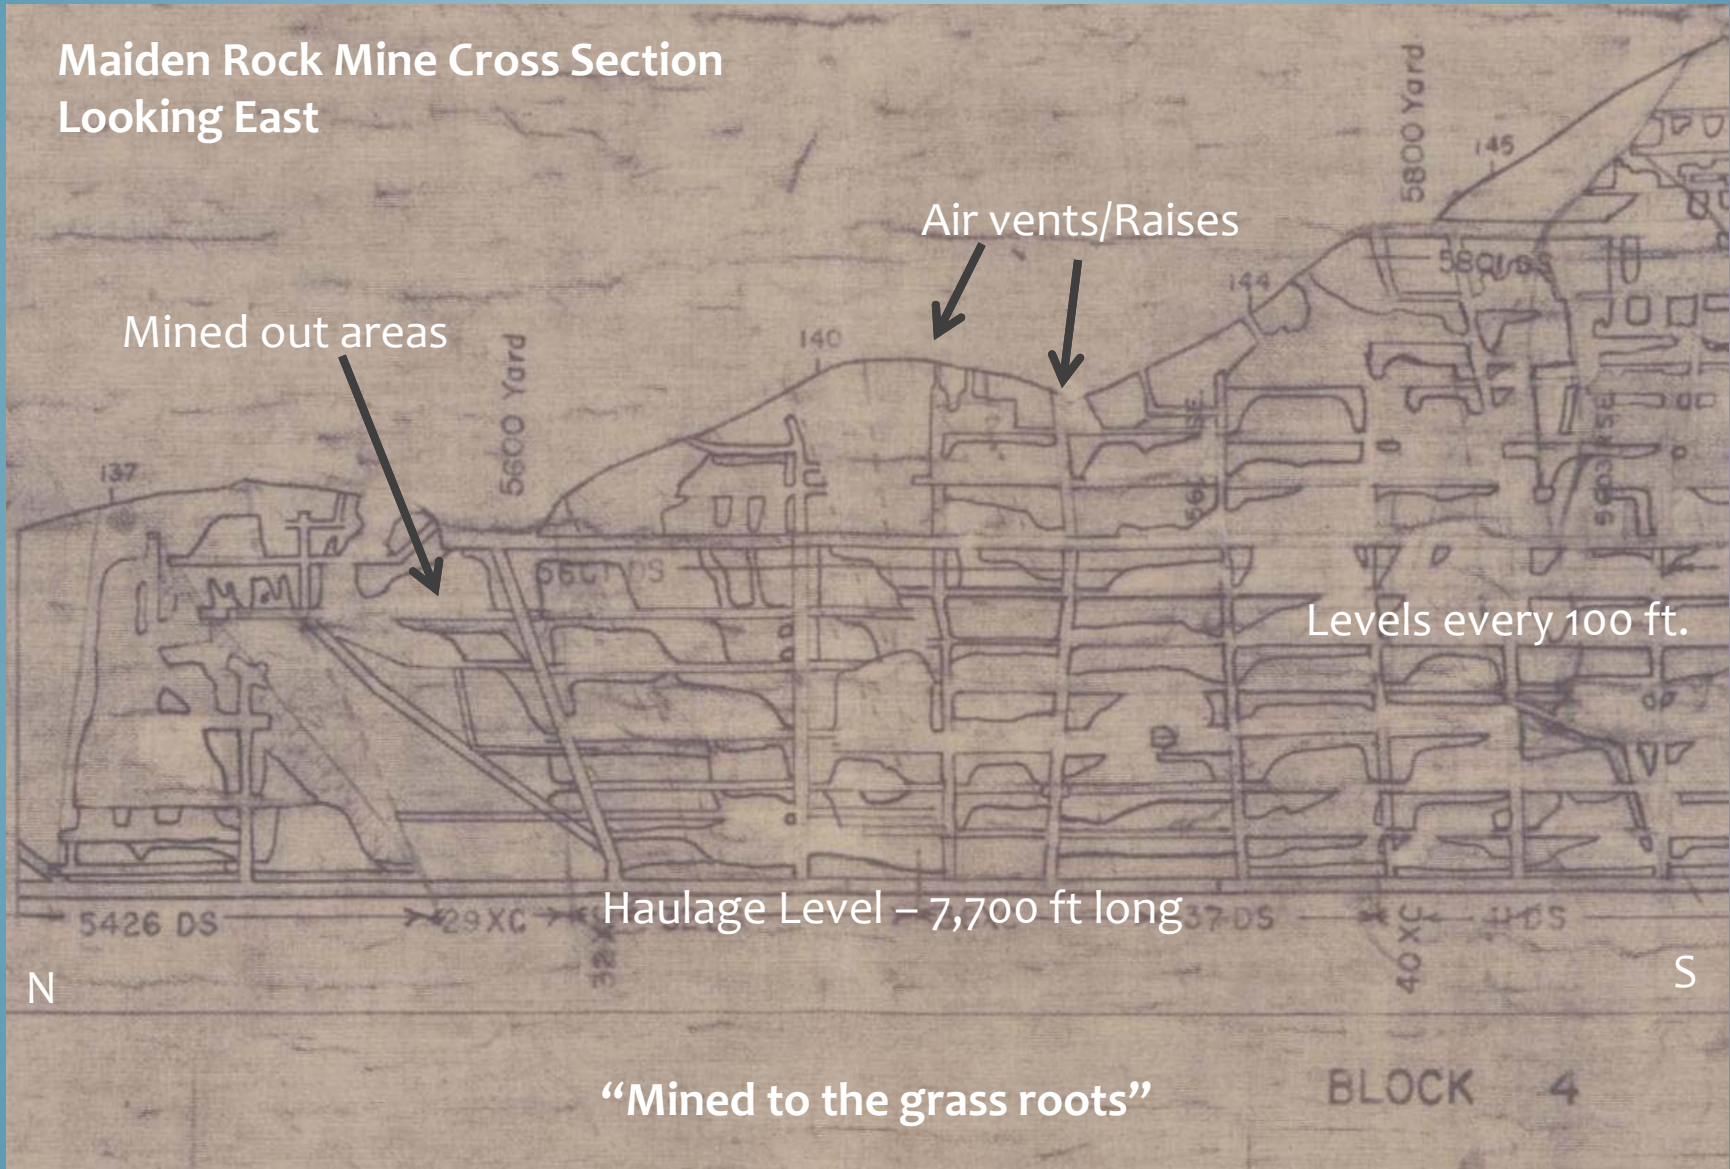
Maiden Rock Mine Cross Section
Looking East

Mined out areas

Air vents/Raises

Levels every 100 ft.

Haulage Level - 7,700 ft long

“Mined to the grass roots”

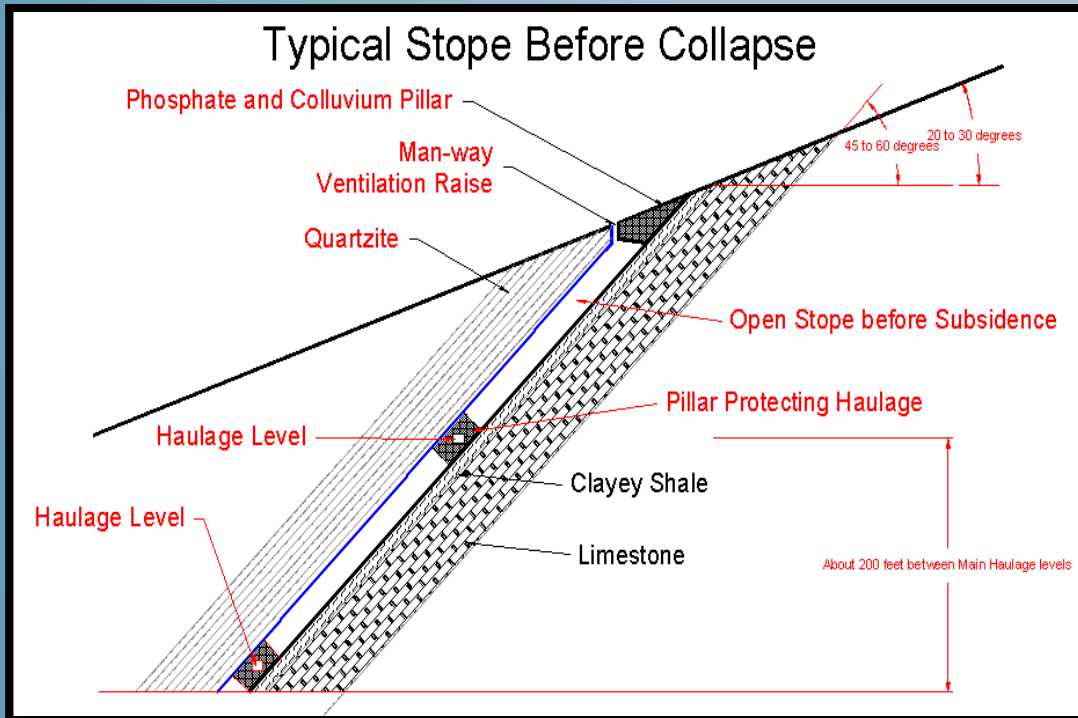
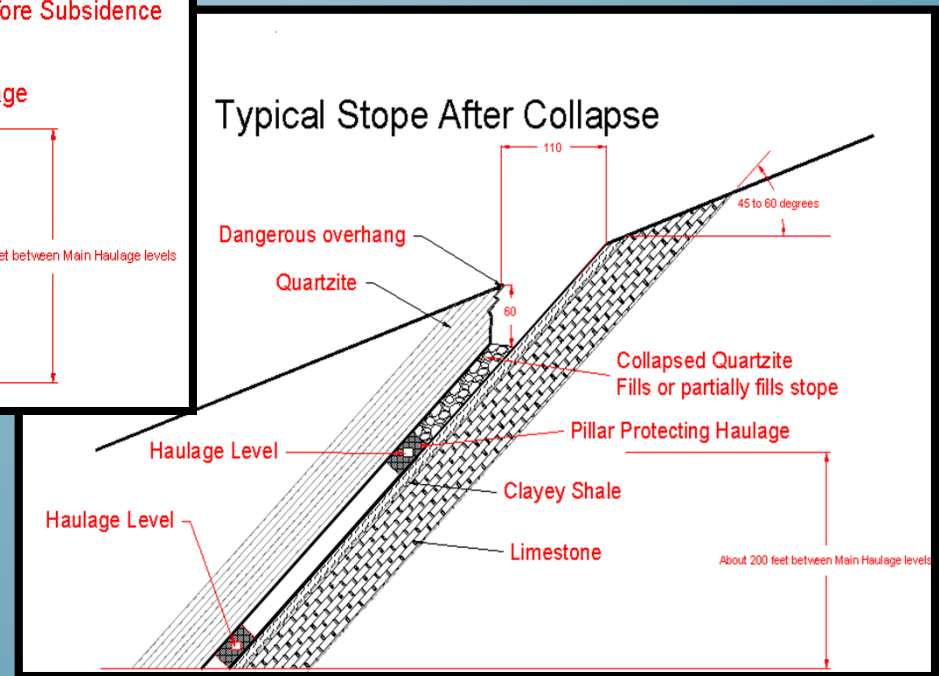
RESULTING SURFACE CONFIGURAITON

- Surface exposure of mines leaves tall highwalls with overhangs
- Extremely hard rock creates difficulty in drilling and blasting down highwalls

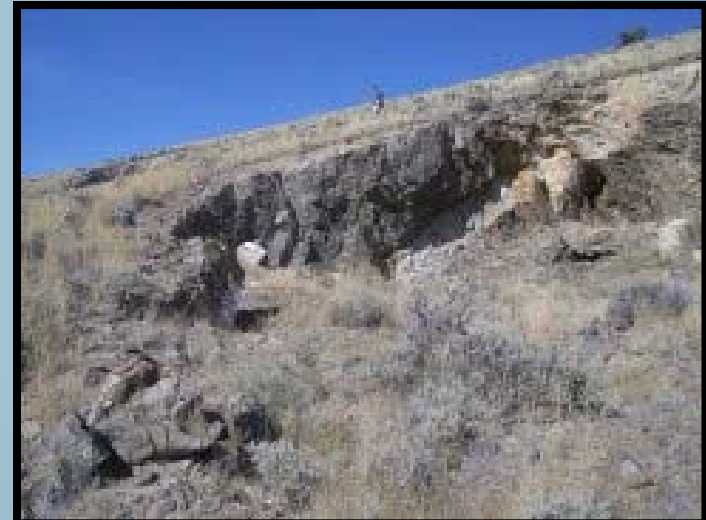
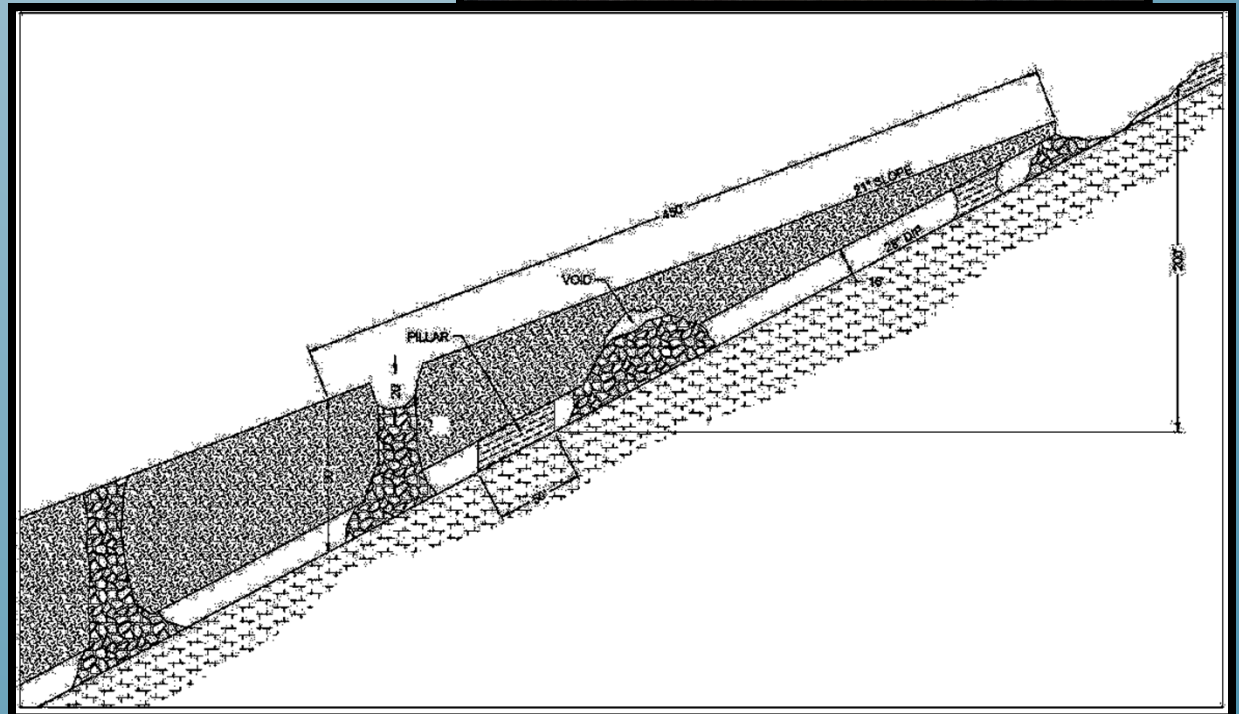
ZONE 1: MOST LIKELY TO FAIL – VERY LOW SEVERITY CONSEQUENCES FOR CONSTRUCTION EQUIPMENT

- Gently dipping bedding - 28°
- Topographic slope 21°
- Thick Ore (17 ft. / Thin beds)
- Sloughed material not run into stopes below
- Large amount of stoping
- Few pillars
- Thicker ore zone 17'
- Very few overhangs
- Stopes choked off
- Likely to have chimney failures

Zone 1

- Work mostly from uphill, and in trenches
- Backfill collapsed stopes with non-adjacent materials, and
- no blasting required

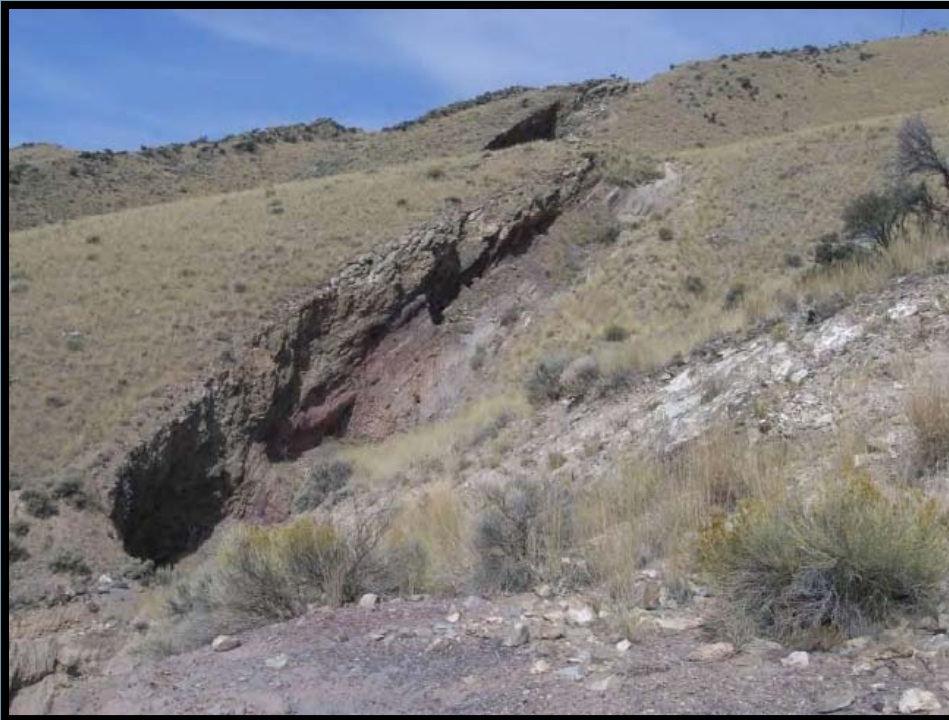
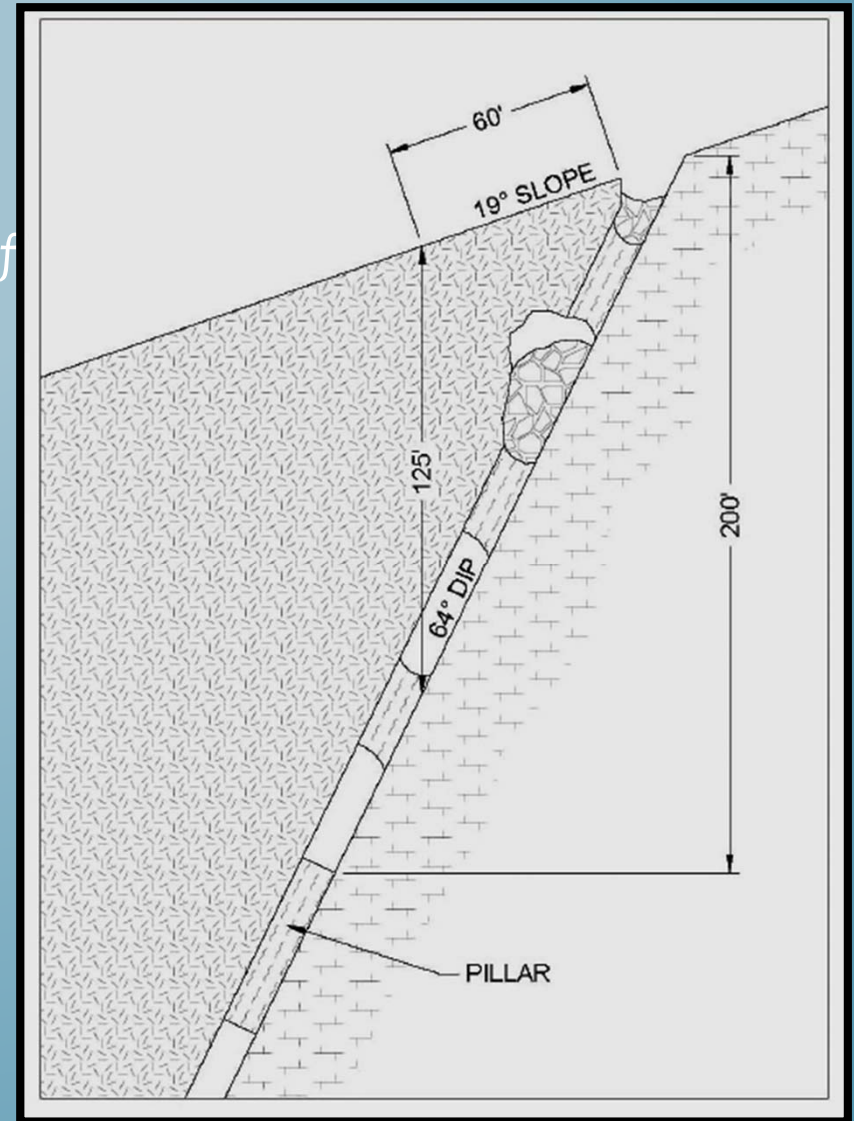
ZONE 3: FAIR PROBABILITY OF FAILURE - LOW SEVERITY OF CONSEQUENCES

- Steeply dipping beds @ 60°
- Topographic slope 23°
- Sloughed material will run into stopes
- Low density of chocking, mostly chocked off
- Numerous pillars

Zone 3

- Equipment work from uphill, and in trenches,
- Significant careful blasting of overhangs required, and
- Possible fencing

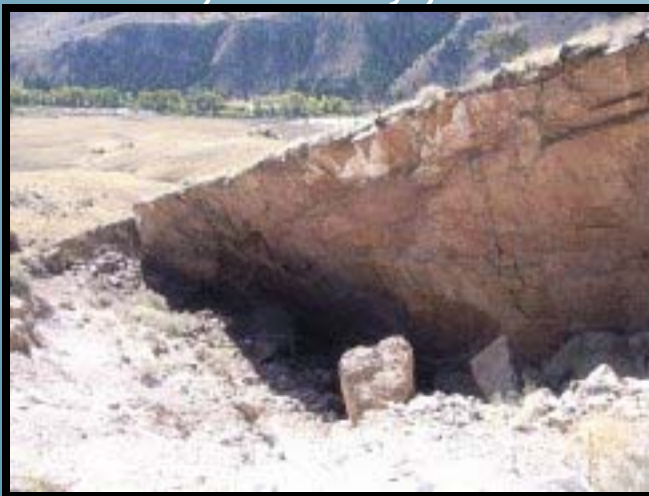
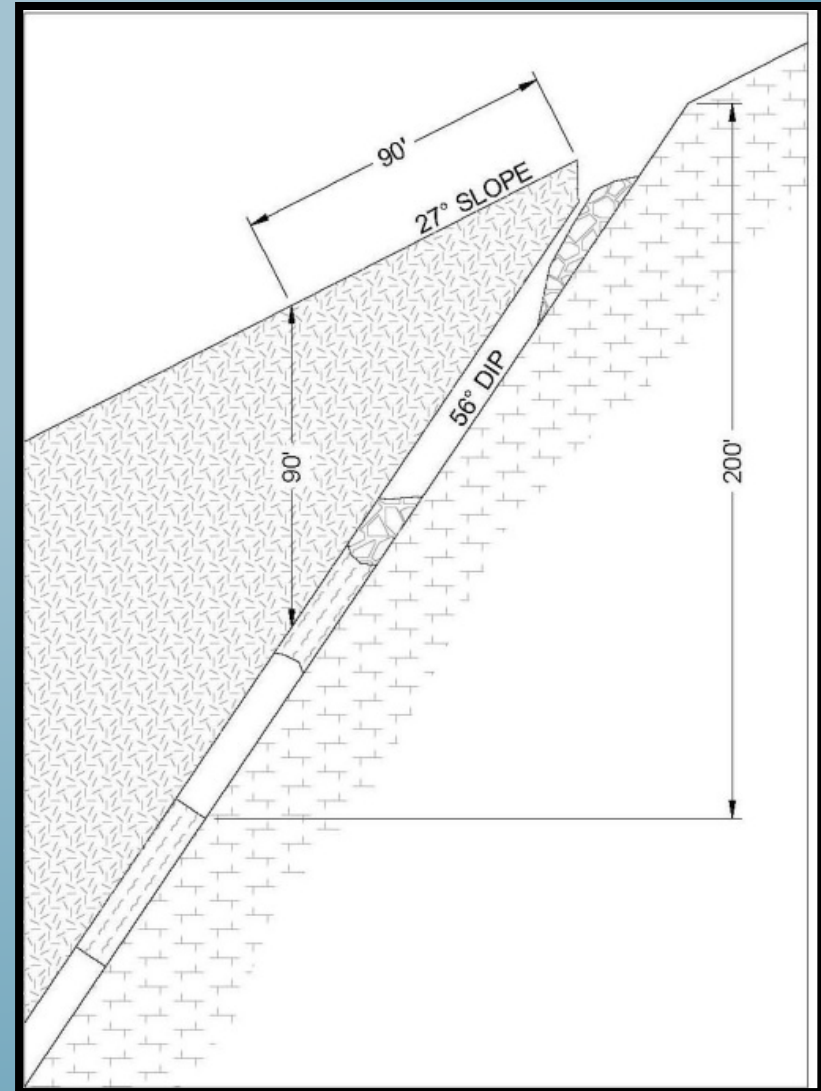
ZONE 4: LIKELY TO FAIL – VERY SEVERE CONSEQUENCES FOR CONSTRUCTION EQUIPMENT

- Steeply dipping bedding 56°
- Topographic slope 27°
- Sloughed material will run into stopes below
- Very large amount of stoping
- Few pillars
- Thin ore zone 10'
- Almost continuous overhangs
- Several areas of open stopes
- Low likelihood of chimney failures

Zone 4

- Equipment work from uphill only
- No blasting of almost continuous overhangs,
- Additional investigations required,
- Fencing required

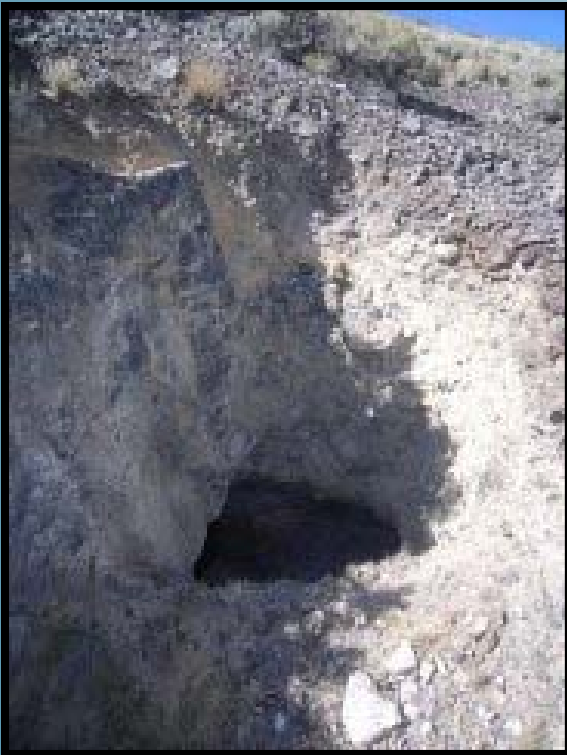
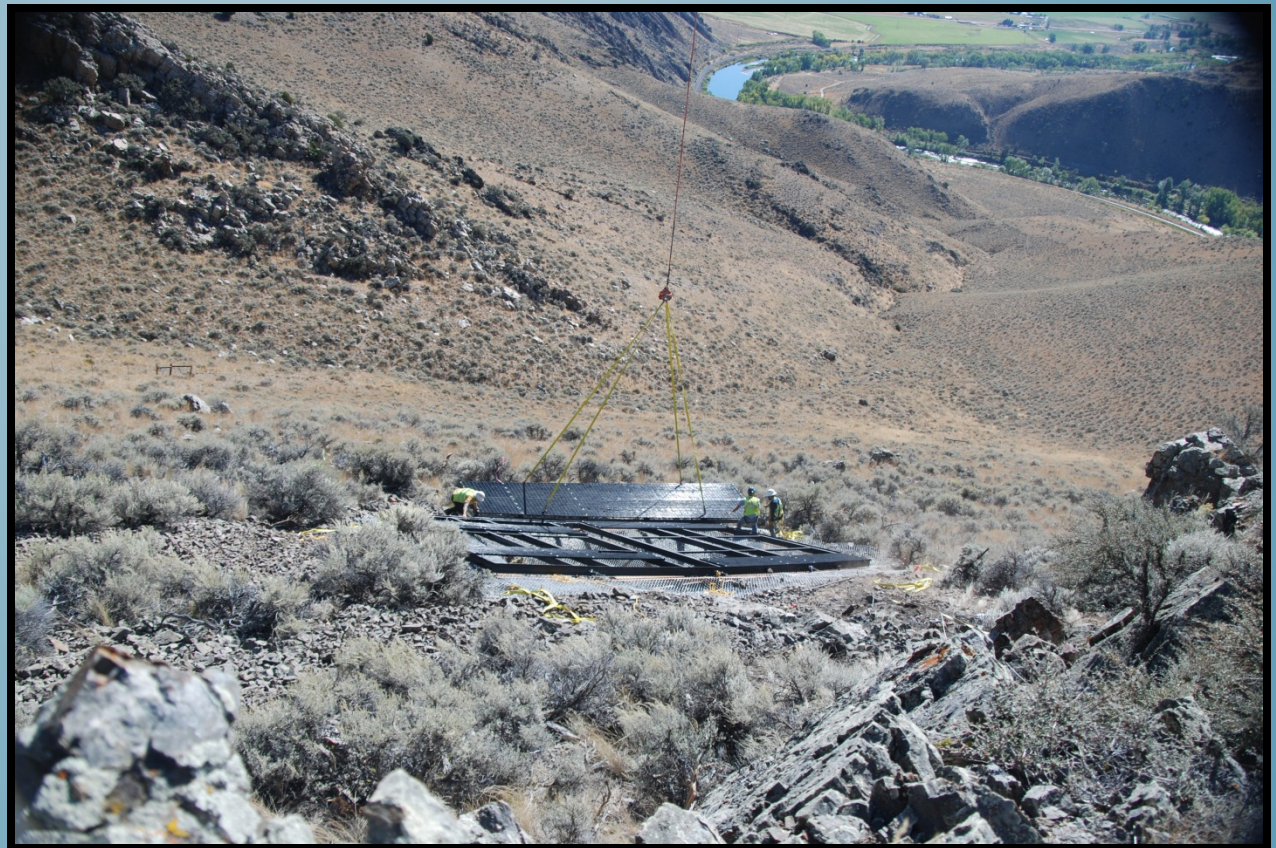
M 153

Zone 1 – thin ground and no access

GRATE INSTALLATION
