CLOSURE OF THE KINROSS DELAMAR MINE

Steve Smith – Environmental Manager – Reclamation Operations (ROBU)

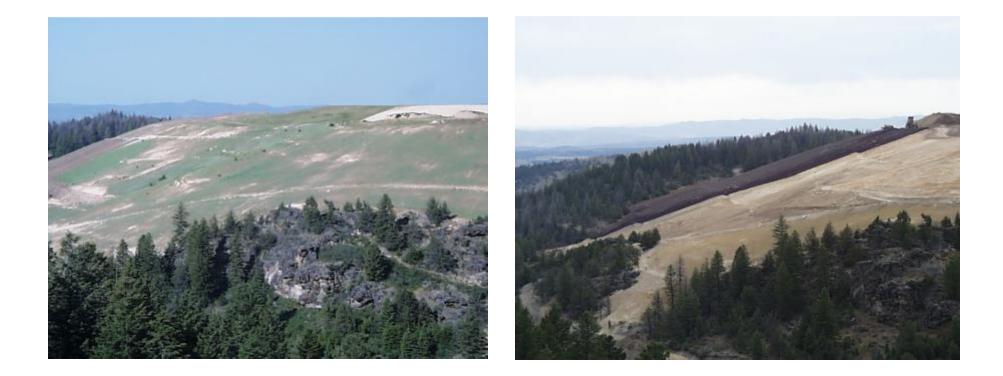
WASTE ROCK #1 CLOSURE -- 2003-2004

• Regraded to 3:1V, low-permeability cover including storm water conveyances

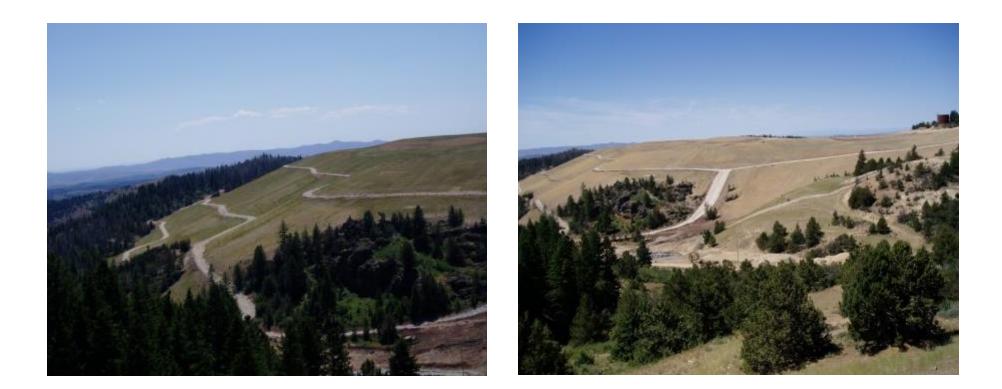
WASTE ROCK #1 CLOSURE -- 2003-2004

- WD1 completed in 2004
- Includes three buried seep collection systems to segregate storm water

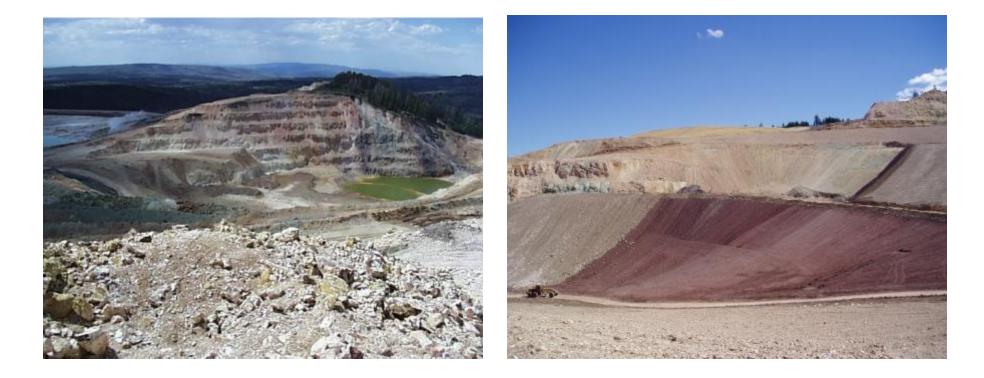
MINE PIT CLOSURE – SOMMERCAMP PIT

- No static groundwater encountered
- Regrade to free-draining topography; backfill deeper, more reactive highwalls
- Construct low-permeability cover

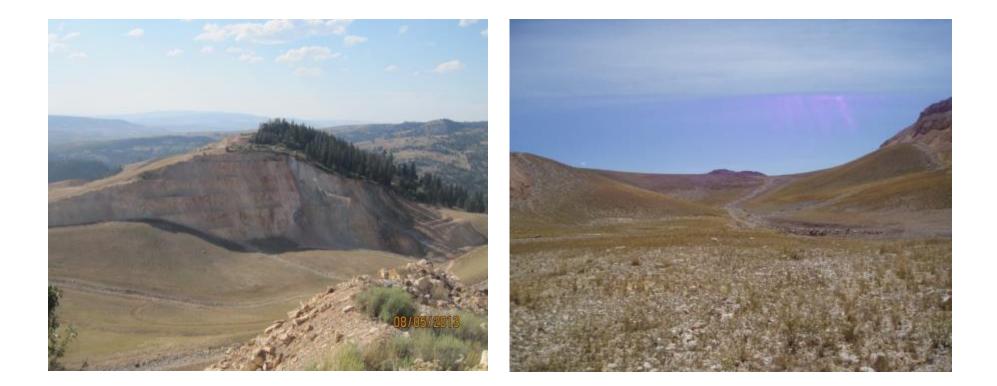
MINE PIT CLOSURE -- SOMMERCAMP PIT

- Completed in 2006
- Storm water free-drains to the north

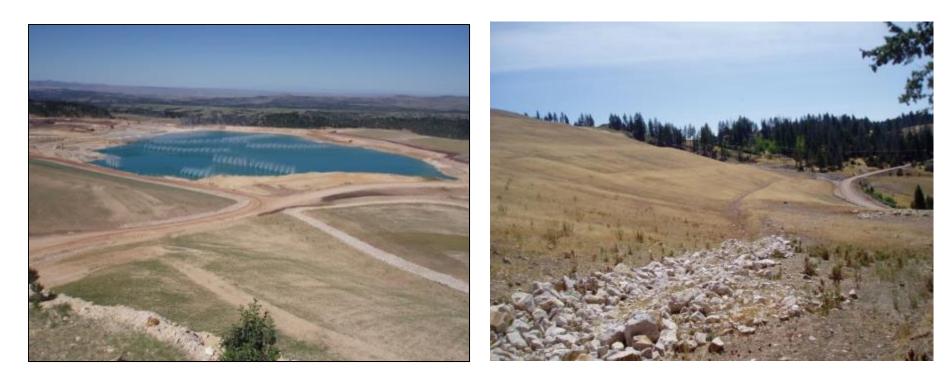
- Continued cover advance with declining water levels
- Foundation instability increasing
- Completed tailings embankment in 2006-2007

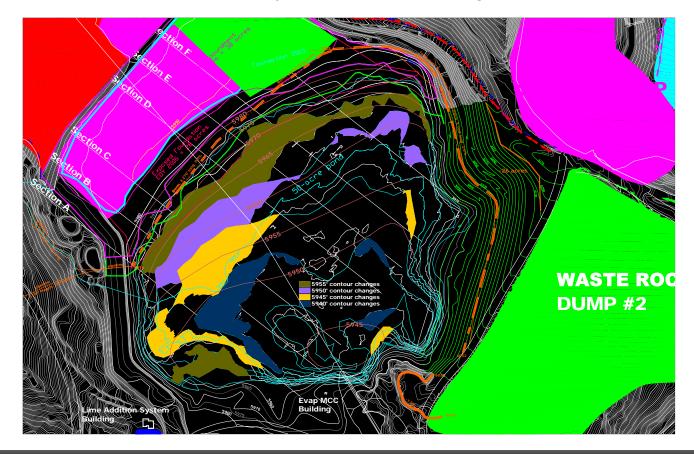
- Stability concerns increased later in the construction season
- Began testing and changing over to smaller, LGP equipment
- October 2006 pond sonar survey; subsurface tailings waves

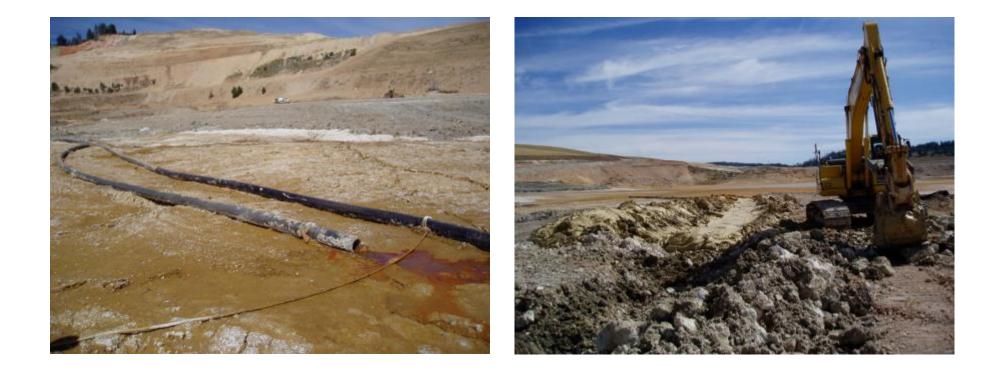
TAILINGS CLOSURE -- WATER ISSUES

- Increase in accumulated pore water drainage and seeps
- Increased water handling, tailings slimes handling
- Prepare to begin spillway excavation
