Remediation of The Block-P Mine Barker Hughesville Mining District, Montana

Chris Neaville
Roger Hoogerheide
Randy Huffsmith

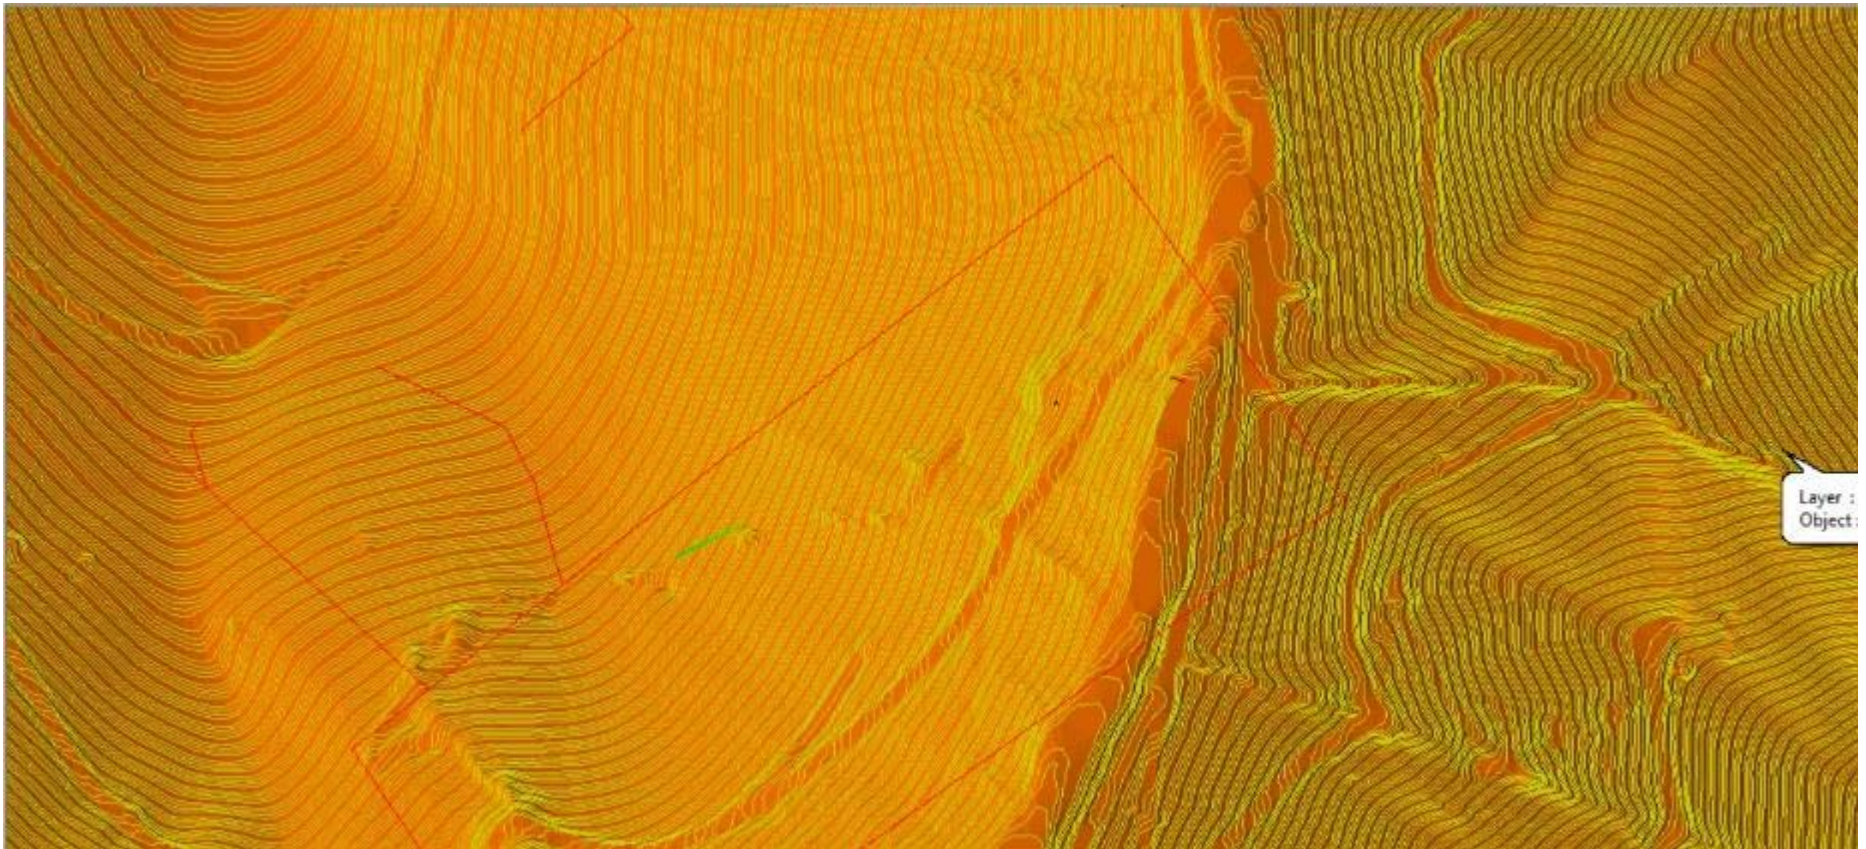
Lidar Helps Reveal the Subsidence Area's

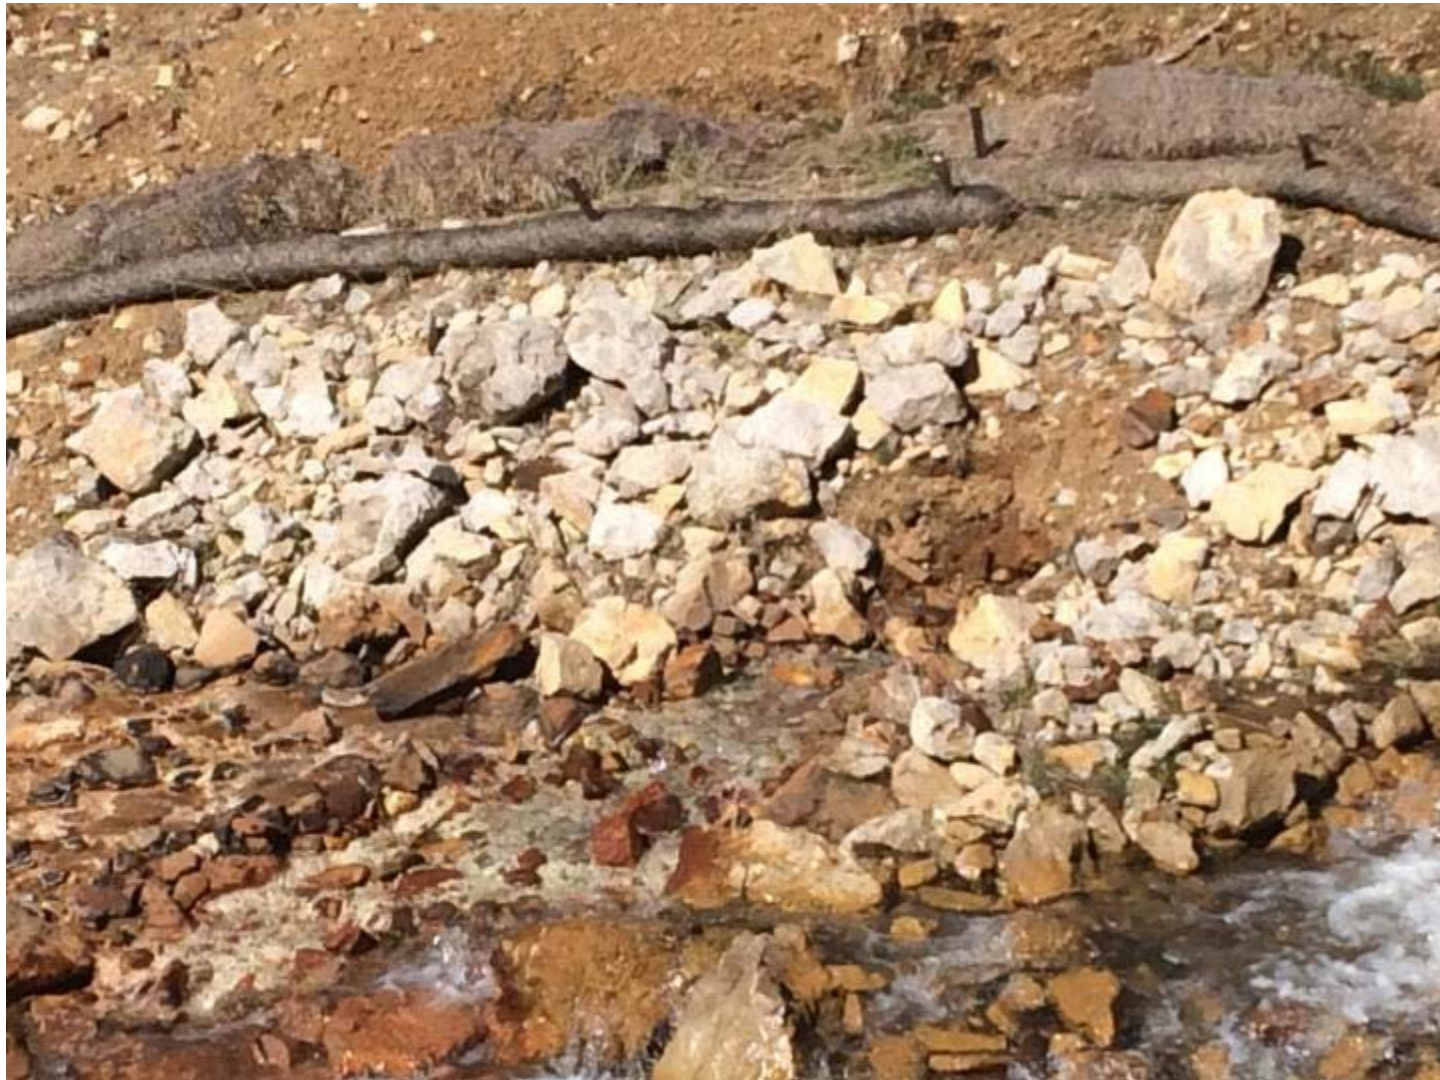
Block P Seep #1 – 25 gpm Pre- Remediation

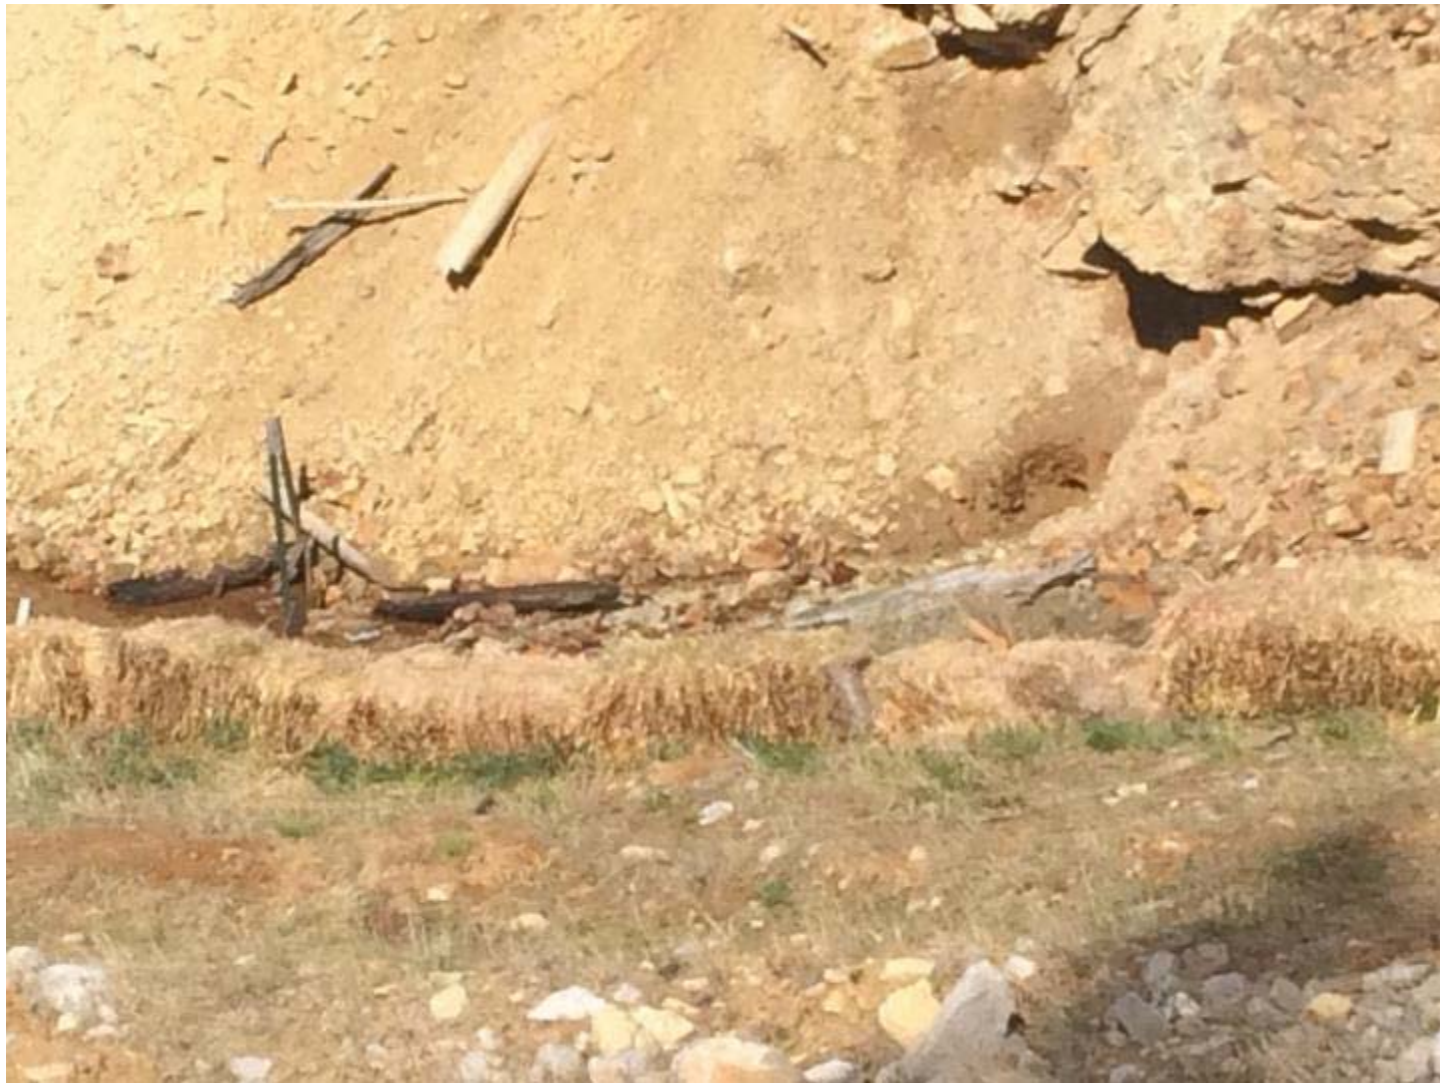
Block P Seep #2 was 25 to 50 GPM Pre -Remediation

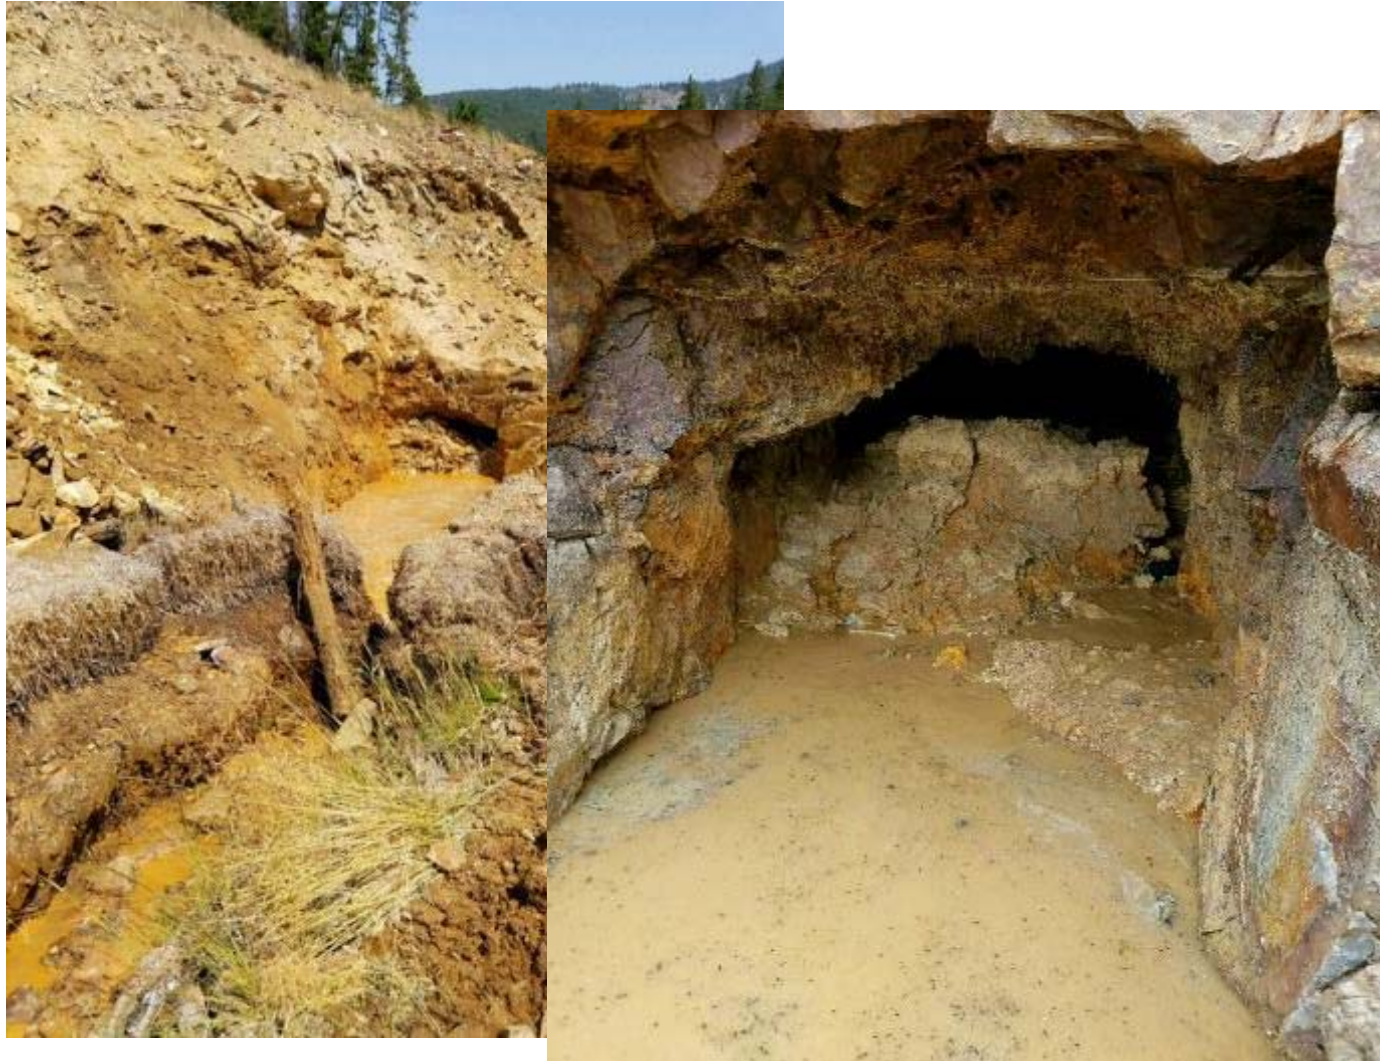
During Plugging, we found that Seep #2 – was a Drift
