AZURITE MINE - CERCLA REMOVAL ACTION PROJECT

**2011 – Mine Design, Operation, & Closure Conference
Dustin G. Wasley, PE, Principal
Cascade Earth Sciences
May 3, 2011**

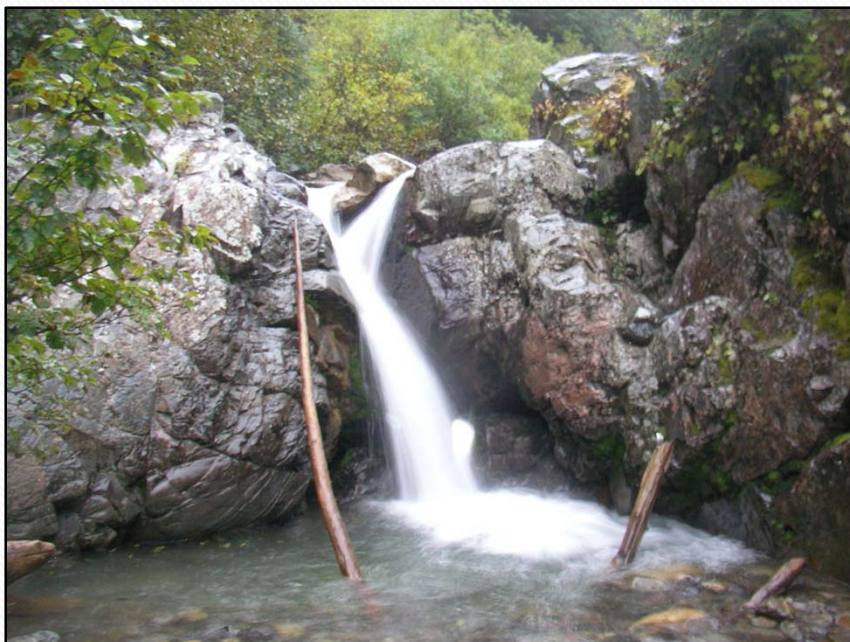
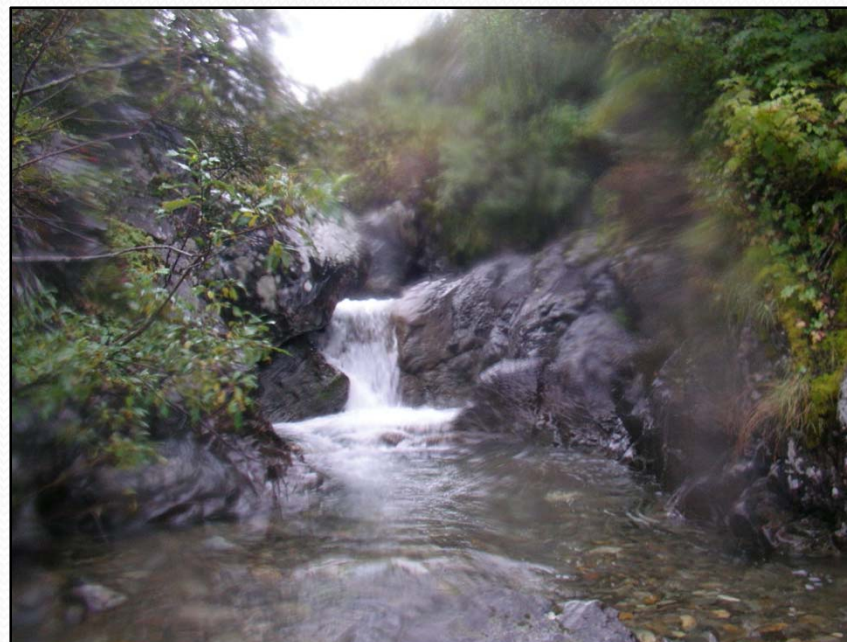
- Mill Creek Fish Barrier Survey
 - Multiple Fish Barriers, No Fish Within 2.5 Miles
