# Beal Mountain Mine

## Leach Pad Problems, Investigation & Closure Plan

**Mine Design, Operations  
& Closure Conference**

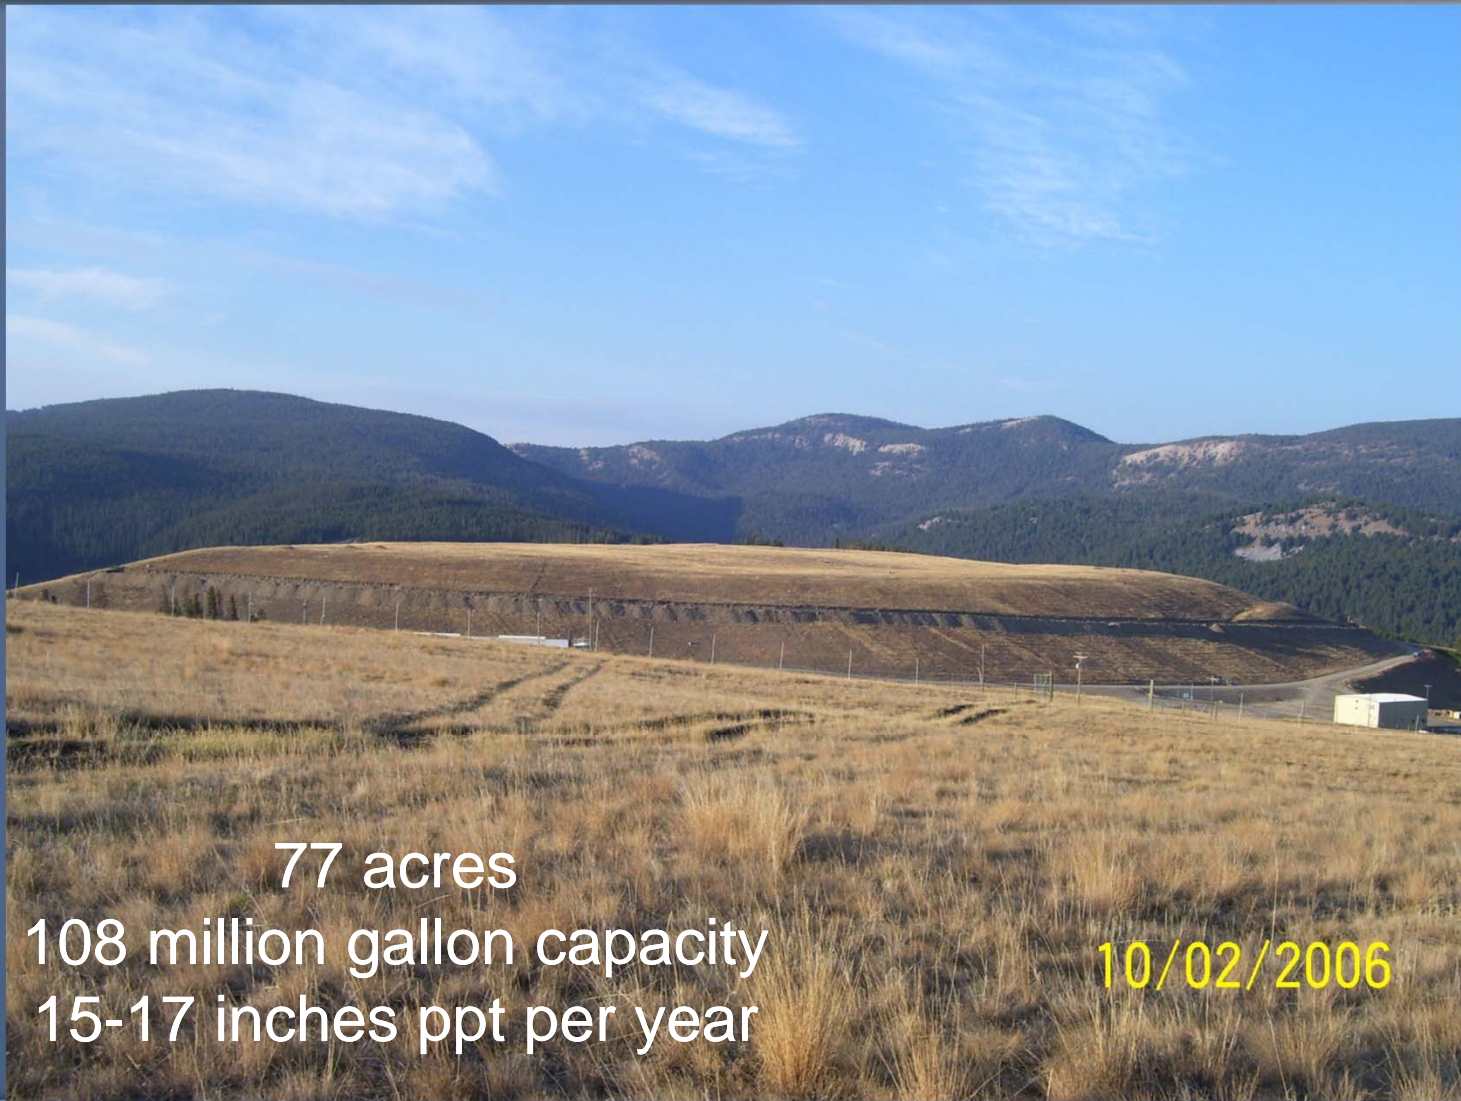
## Beal Heap Leach Pad – looking west

77 acres  
108 million gallon capacity  
15-17 inches ppt per year

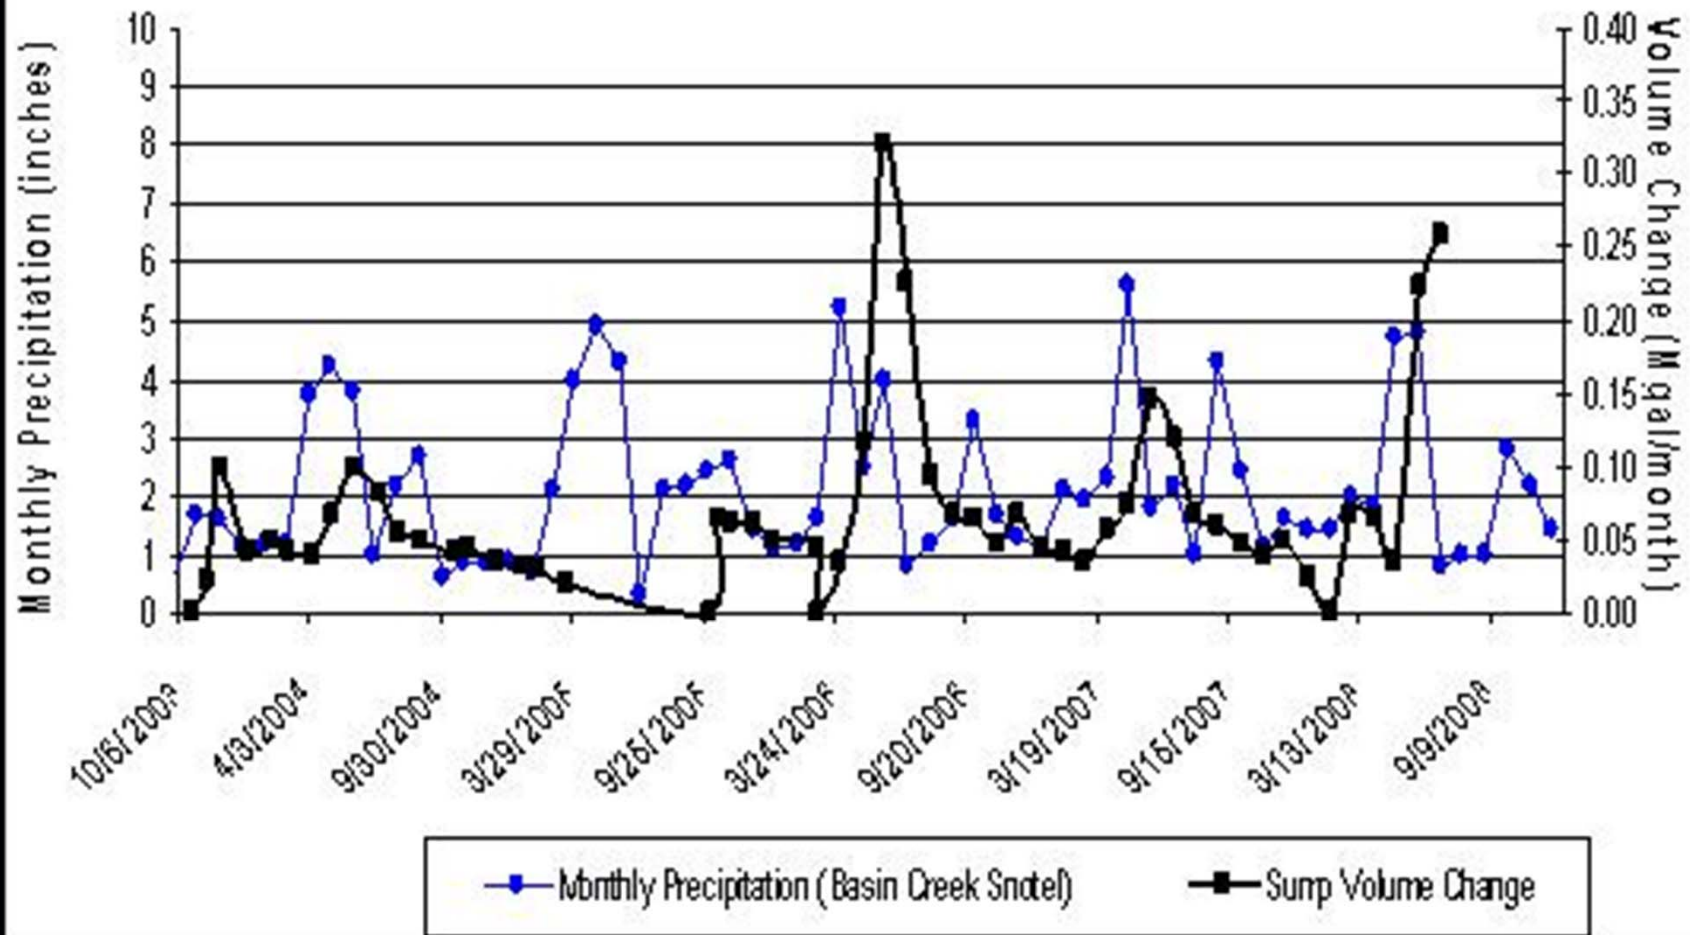
# Leach Pad – Monthly Precipitation vs. Volume Change

Follows annual Precipitation and GW hydrograph

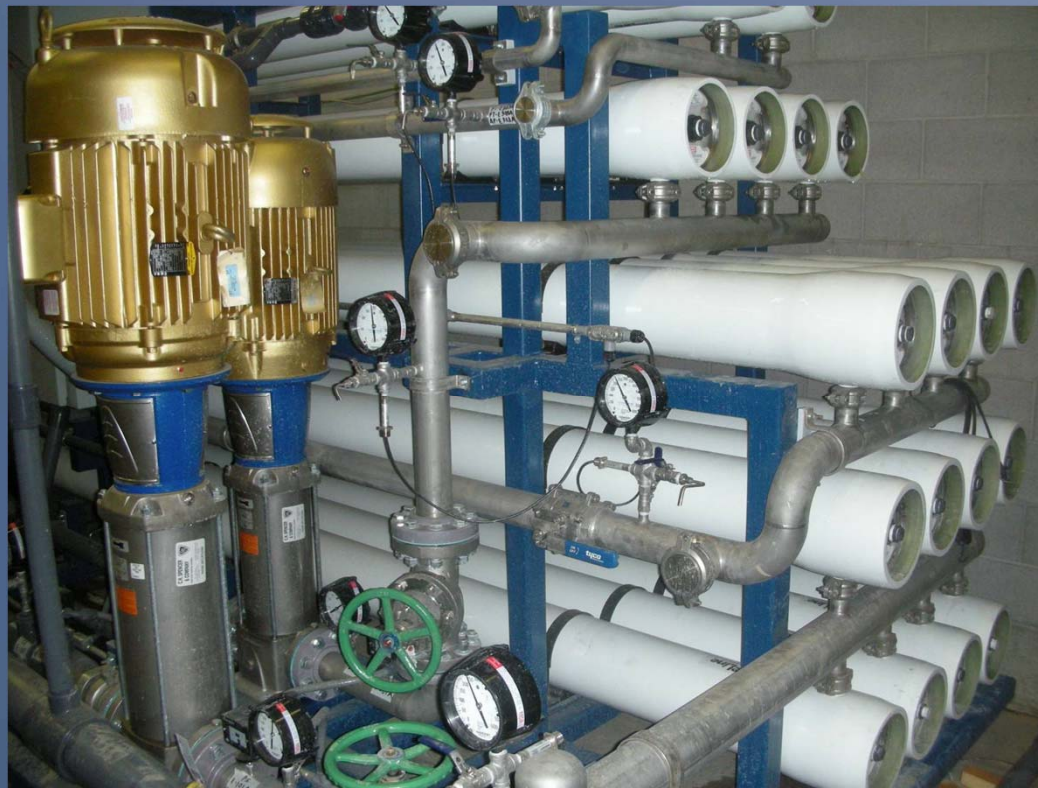
RO Treatment System

- Water is of very poor quality and needs to be treated before discharge
- Water must be treated to maintain reasonable water levels on the pad (no overflow, minimize risk of failure)

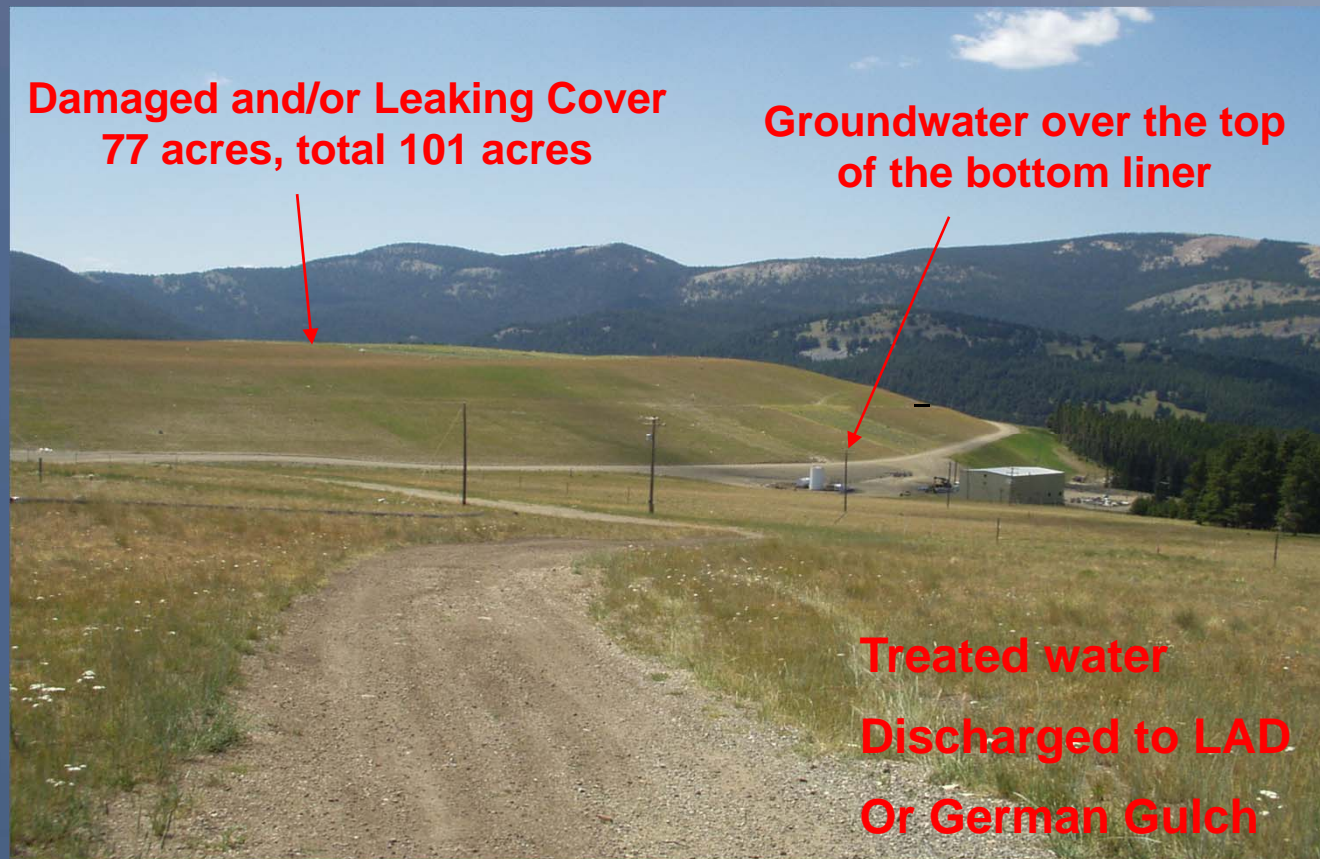
# Heap Leach Pad Potential Excess Water Sources

- Possibilities -
  - Leaking through geotextile cover on pad
  - Water entering over the top of the bottom liner

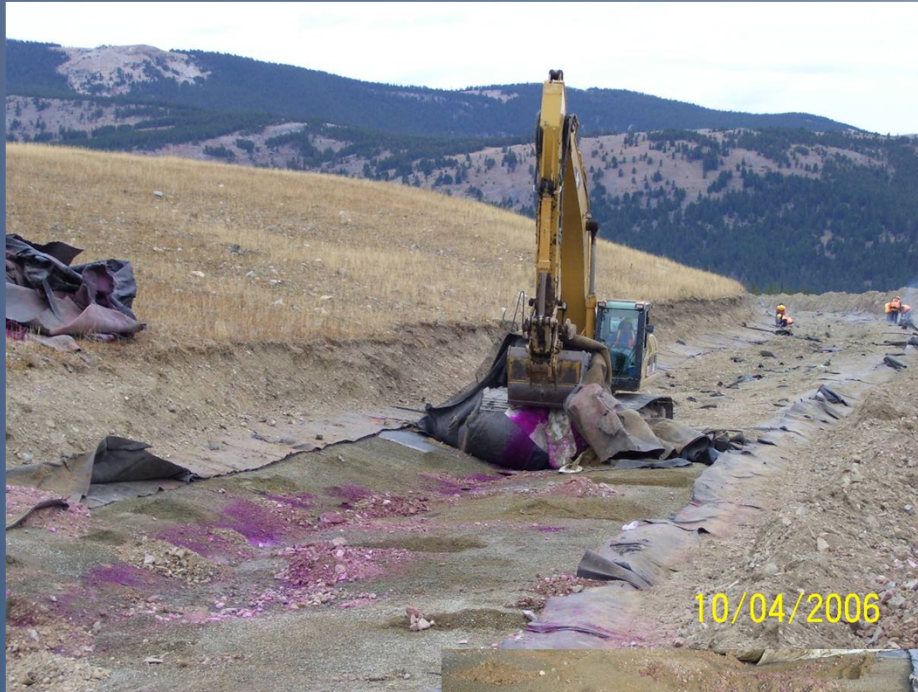
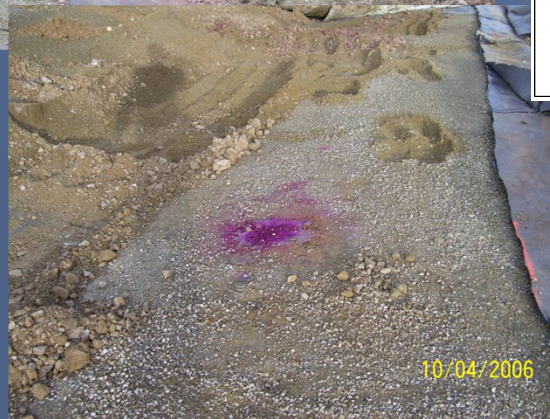
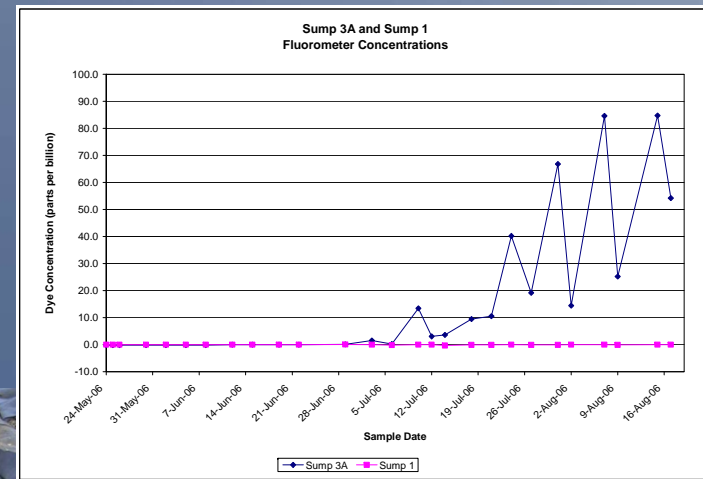
# SW Interceptor Ditch - Dye Tracer Investigation

PVC Joints lapped  
the wrong way

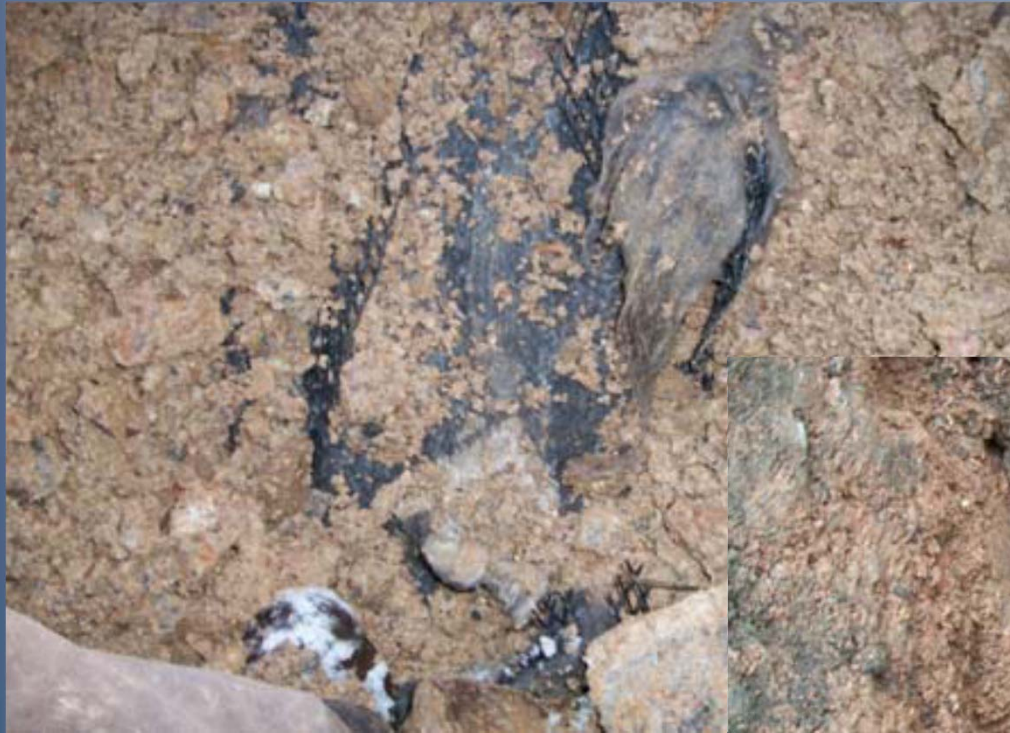
TP-5 dry

## Cover Test Pits (wet and dry)

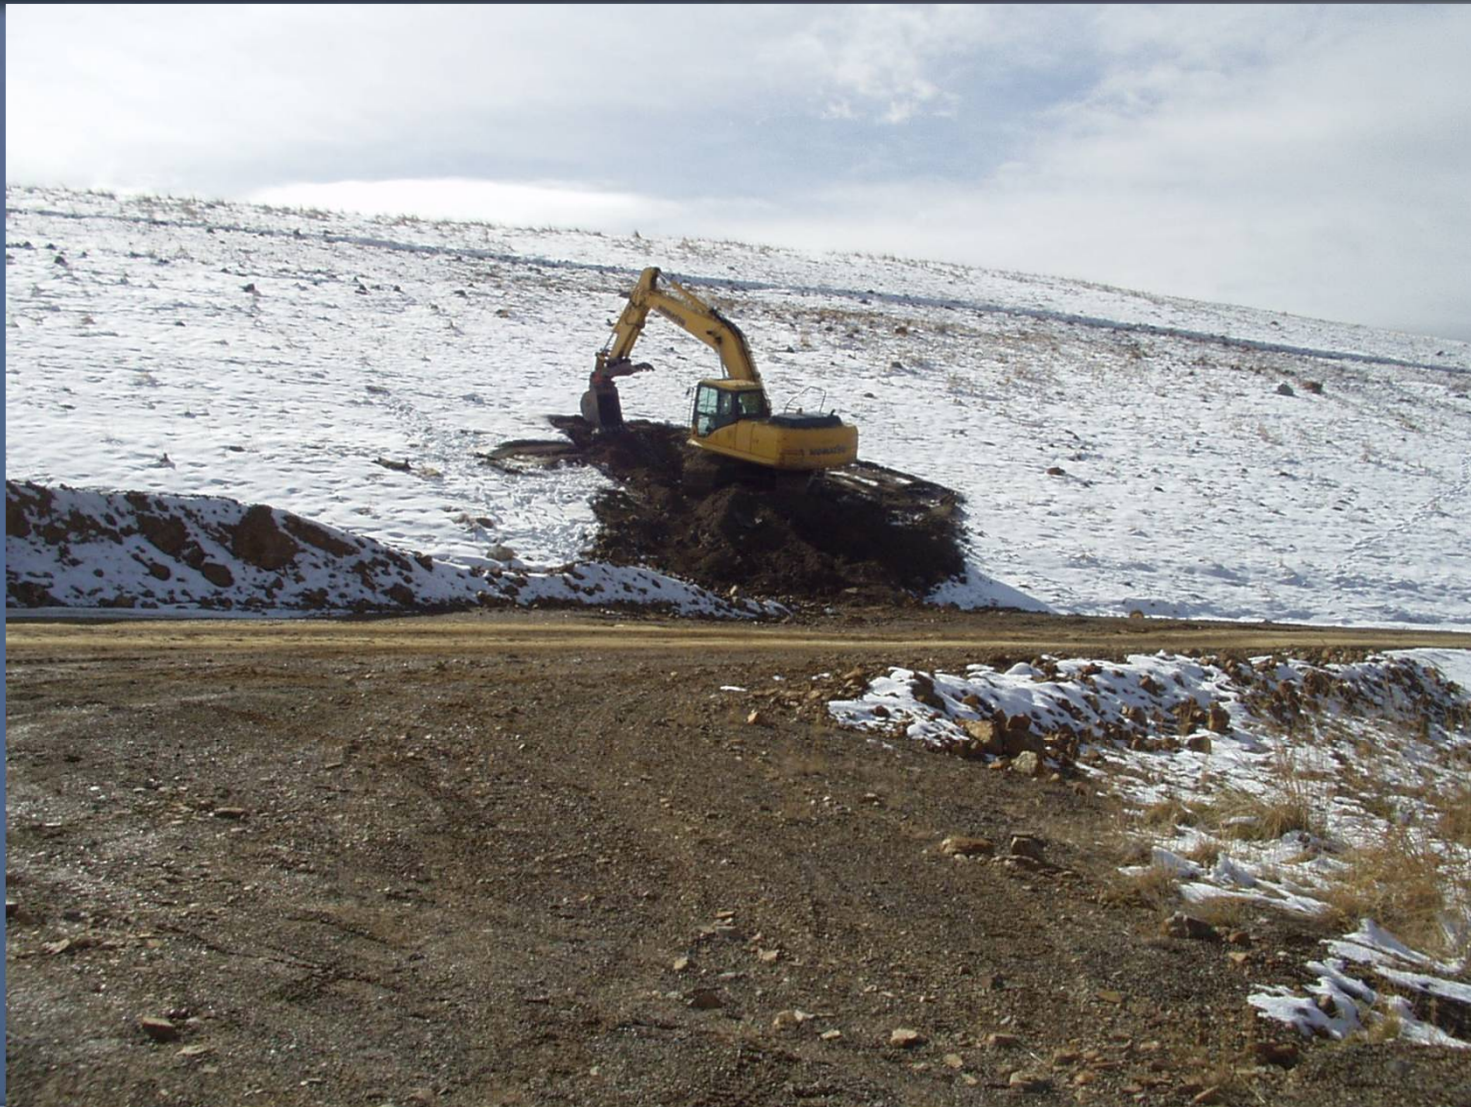
# Leach Pad Perimeter Trenches

11 perimeter trenches

- ▲ Monitoring Well
- Leach Pad Bump
- Abandoned Leach Pad Sump
- ▲ 106  
7437.07  
Local Coordinate Control Point  
and Elevation (Feet)

- ▲ LPMW-2 2008 Leach Pad Investigation Monitoring Well
- ▲ LPPZ-2 2008 Leach Pad Investigation Plasmometer Well
- 0+00  
+0+50  
1  
2008 - 2010 Leach  
Pad Trenches

- 2010-LP-TP-1 2010 Leach Pad Trench Stake Locations
- - - Edge of Existing Cover
- Projection of Pegasus Stage 3 Bottom Liner

Beal Mountain Mine  
2010 Leach Pad Phase II Investigation  
Trench Plan View  
Silver Bow County, Montana  
FIGURE 4

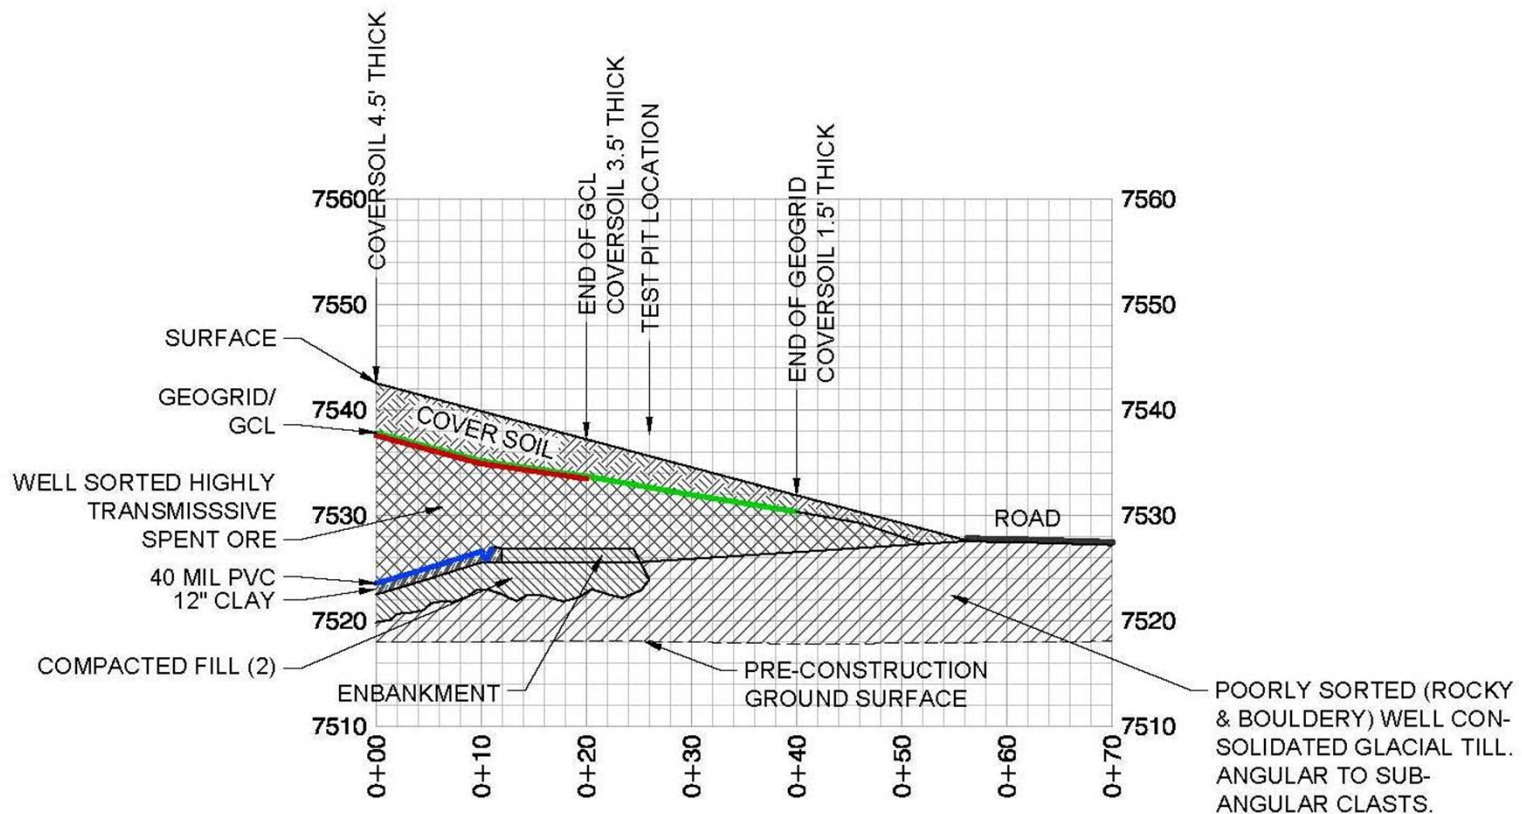
Leach Pad Trench 1  
1" = 40'

# Leach Pad Perimeter Trench #1 – Cross-Section Results

Spent ore graded off the pad  
Cover Extents -GCL termination

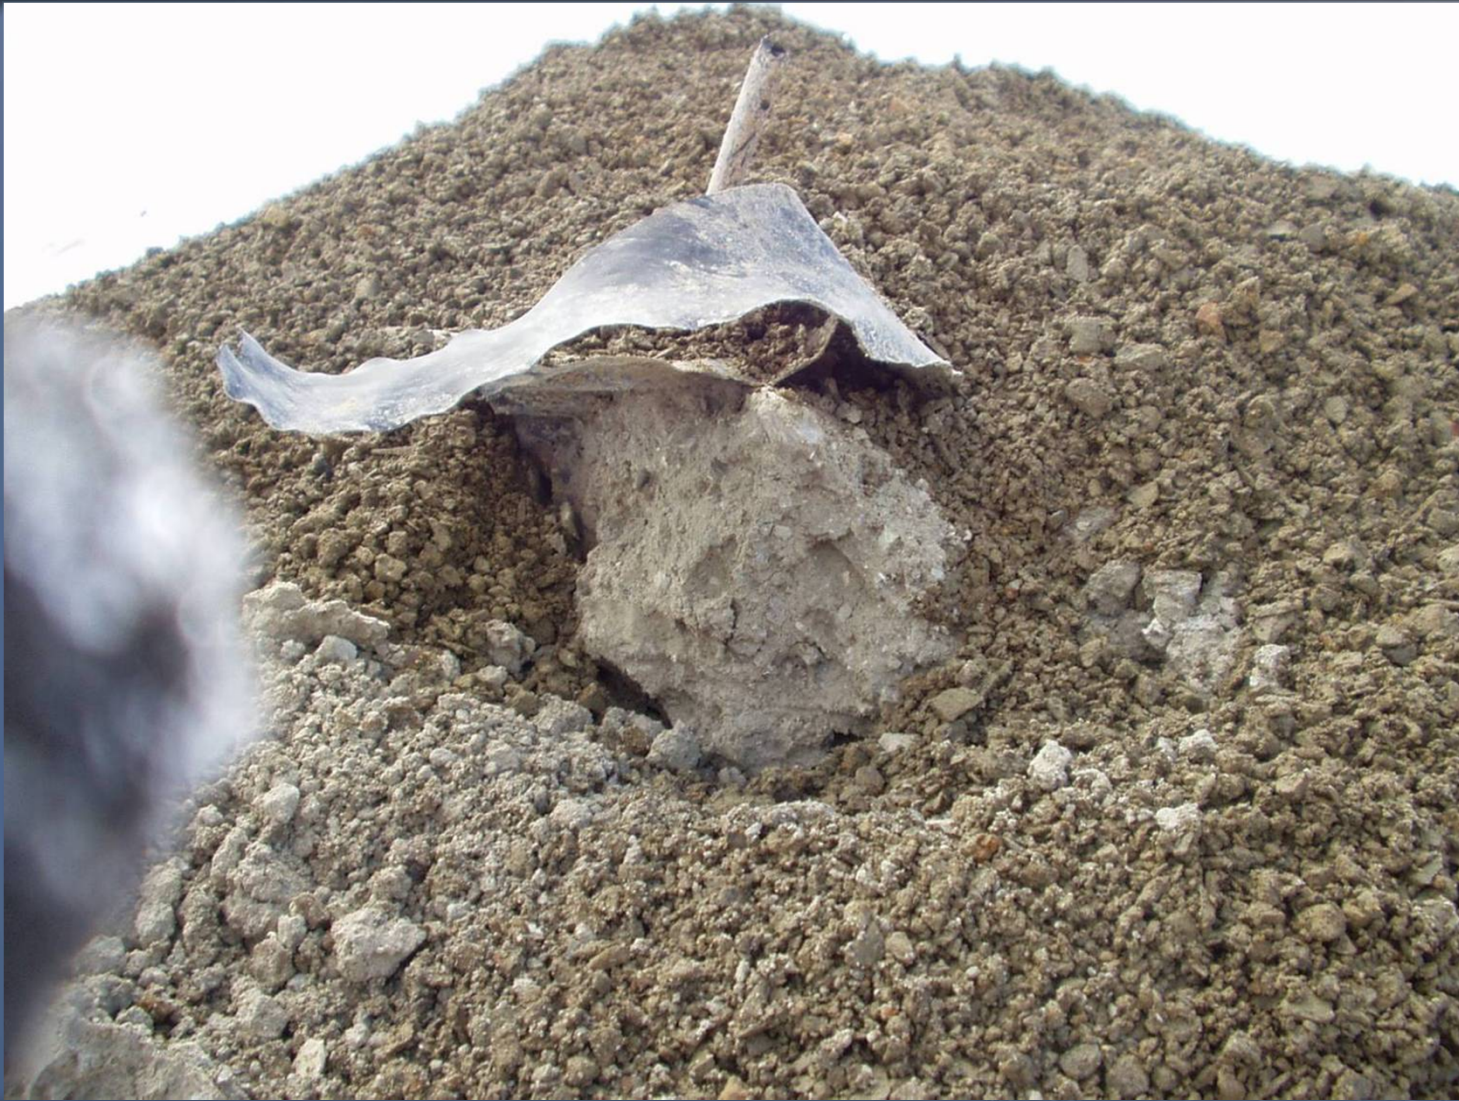
## Spent Ore is Highly Transmissive

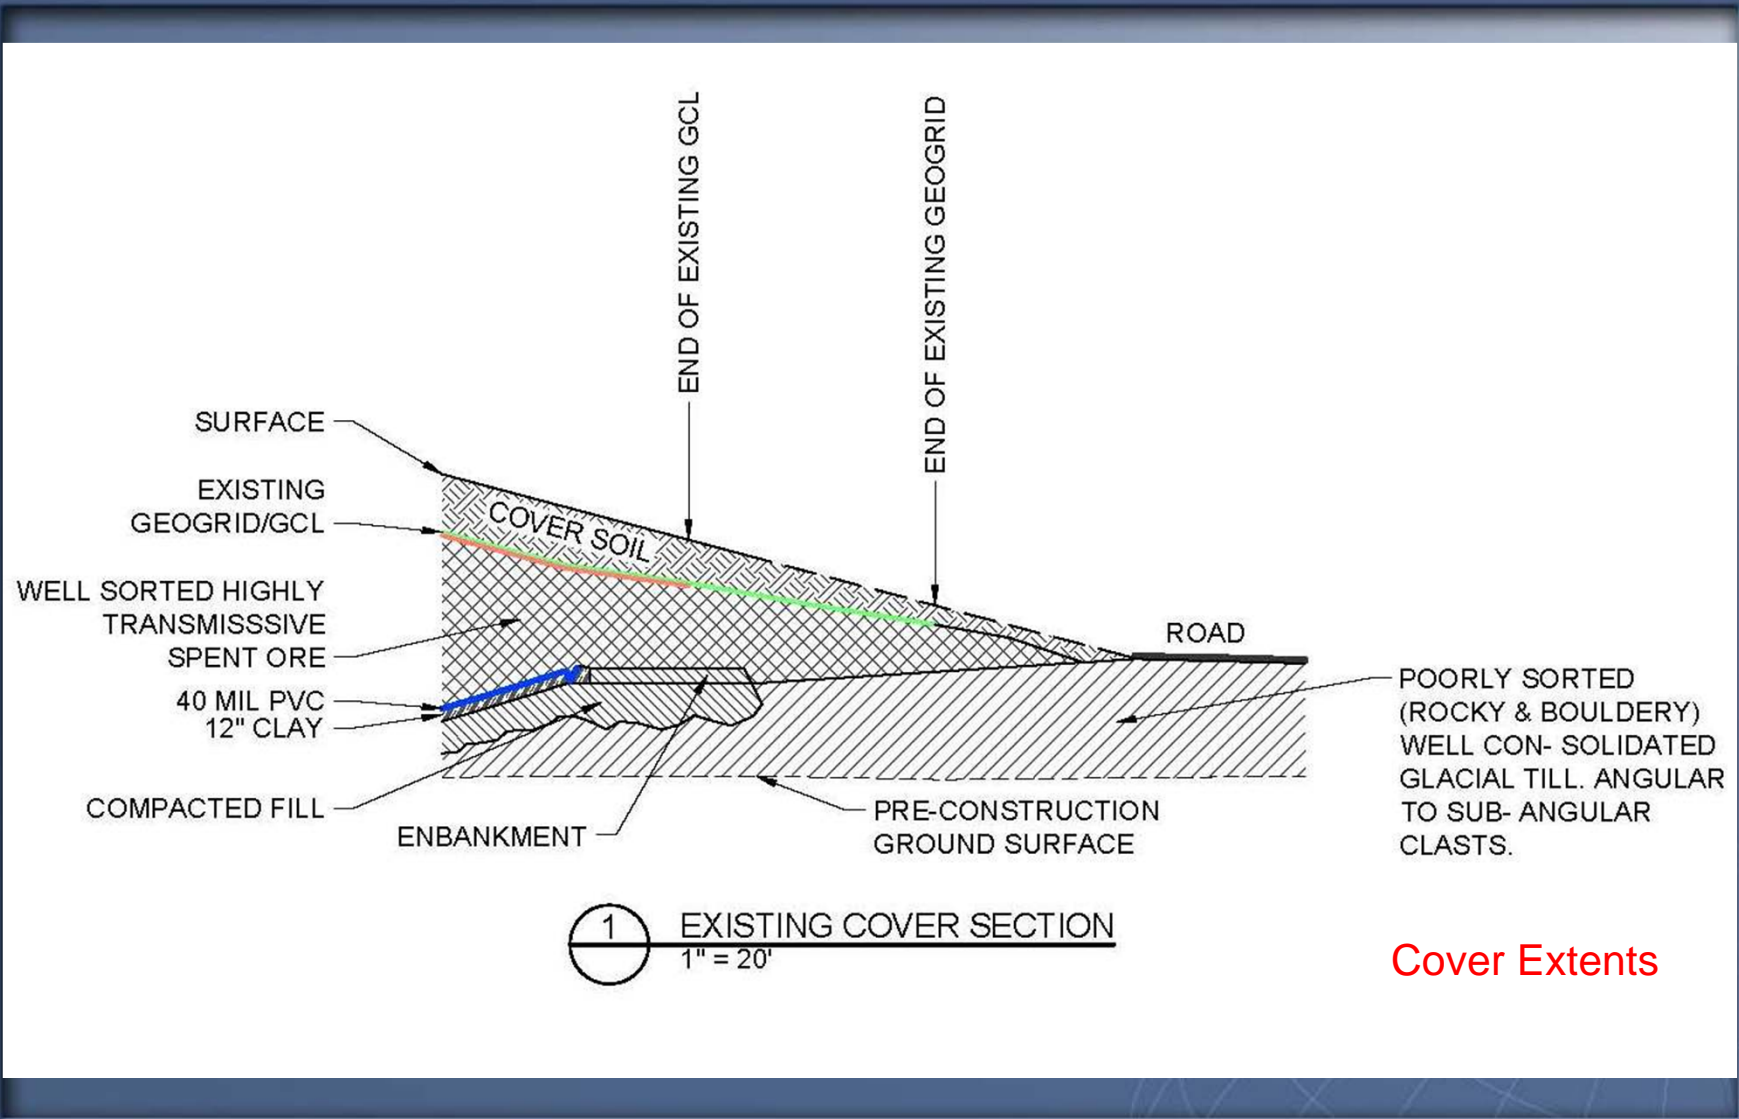
# Leach Pad - the Problem

Cover Extents
