CERCLA Removal Action At The Rainy Mine, Washington

Robert H. Lambeth, PE, PG, LHG & Paul Hunter, PG
Millennium Science & Engineering, Inc.
Spokane, Washington

*MINE DESIGN, OPERATIONS
& CLOSURE CONFERENCE*
Fairmont Hot Springs, Montana
May 2, 2012

**Wells-MSE Performed The Reclamation
At the Rainy Mine as a CERCLA Removal
Action Under Our ID/IQ Contract With
Region 6 Of The U.S. Forest Service,
Mount Baker-Snoqualmie
National Forest**

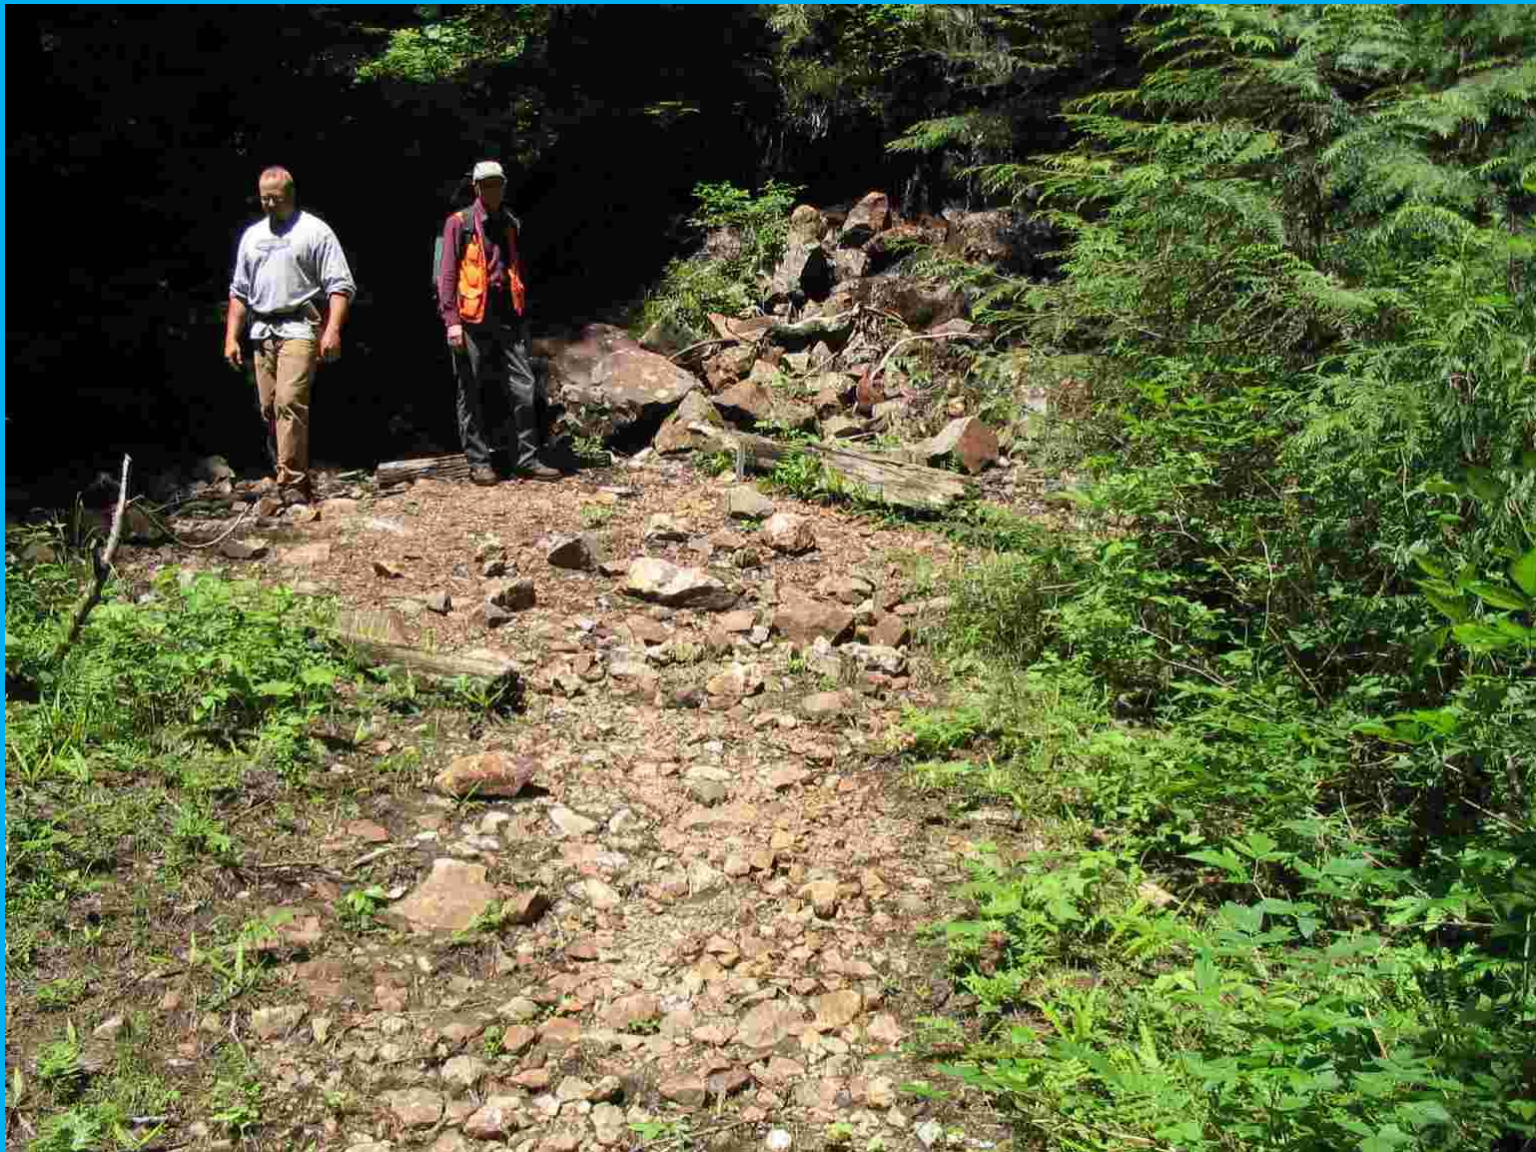
WR-2 Adit

- Anticipated waste volume was 2,000 cy
- A burned, crushed, and covered mill structure was discovered during excavation that added an additional 700 cy
- The shaft was expected to hold 200 cy, but held 1,200 cy
- 1,800 cy was taken to the repository
- WR-2 was expected to be 25 cy, but was actually 250 cy
- Excavation at WR-2 was terminated after calculating a new “local” background

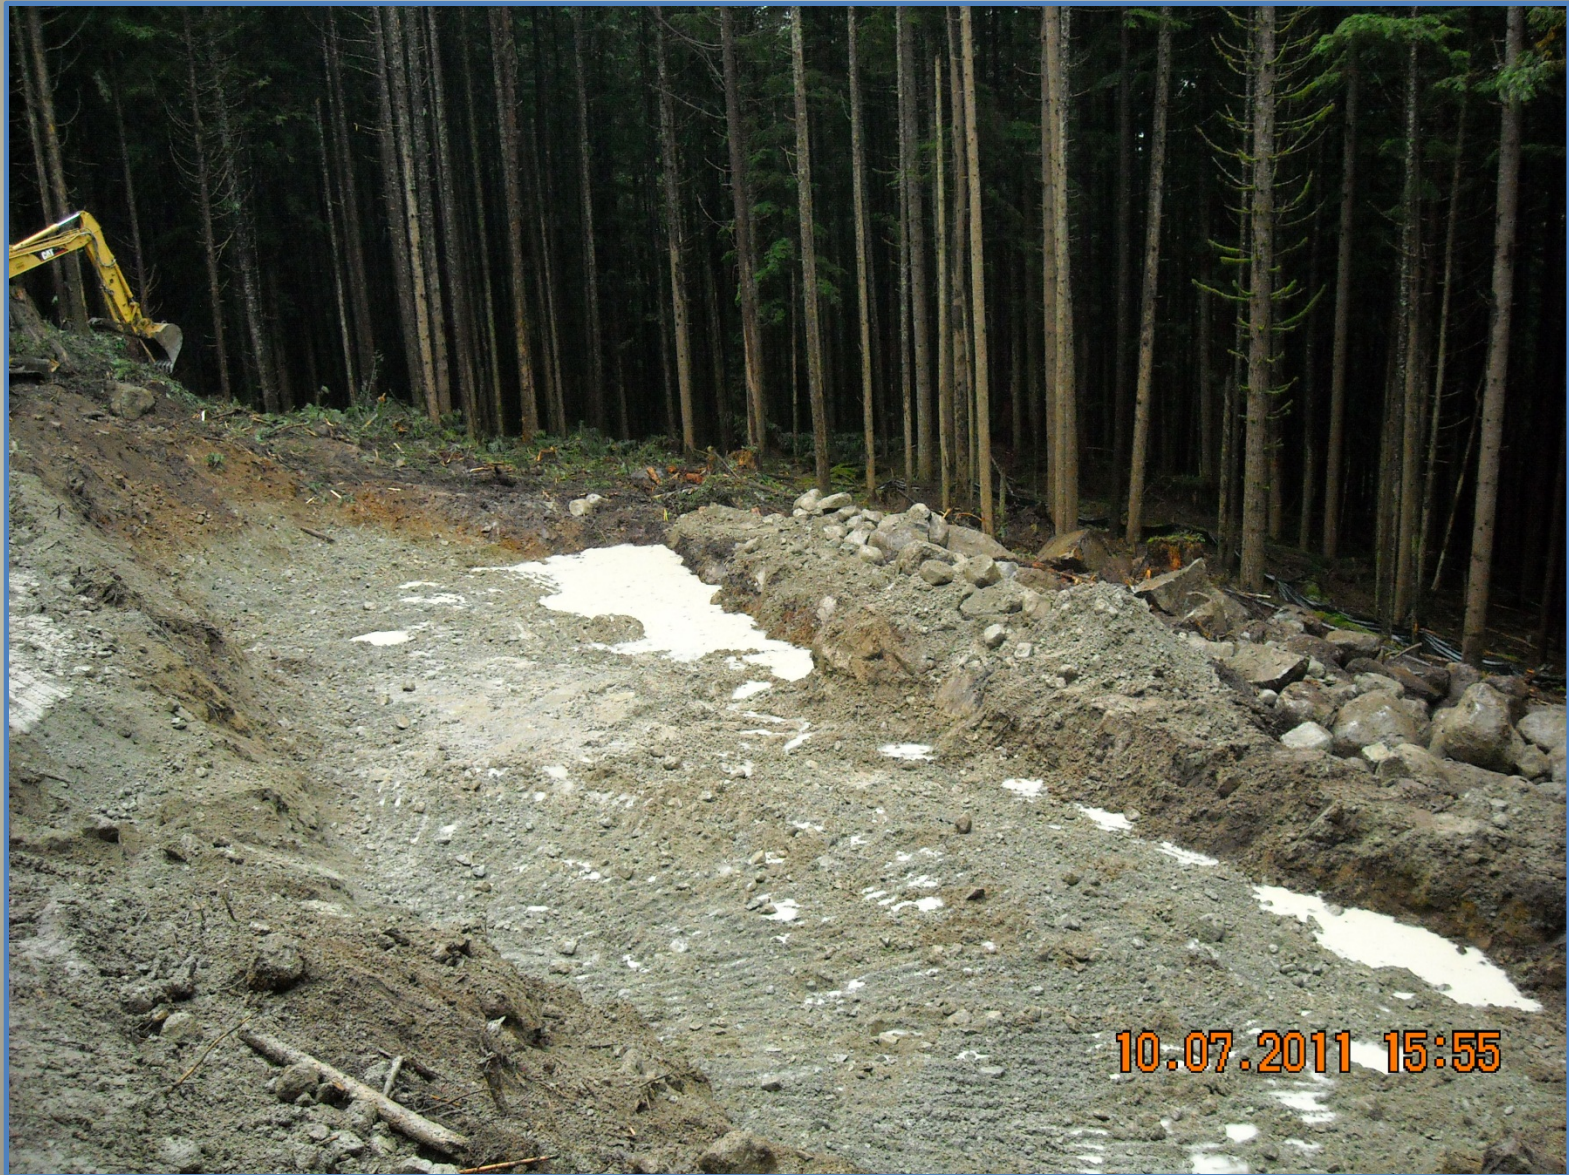
Repository Pit

- Water in the repository pit was clearly identified as groundwater, not precipitation
- A drainline was installed to intercept the groundwater
- The effluent was piped to an infiltration basin filled with coarse rock
- The basin was covered with geotech fabric, then soil and moss
