Rumsey Mill & Fred Burr Creek Site Characterization

Fred Burr Creek - Rumsey Mill Site
 Mercury Soil Sample Results - Detail Map

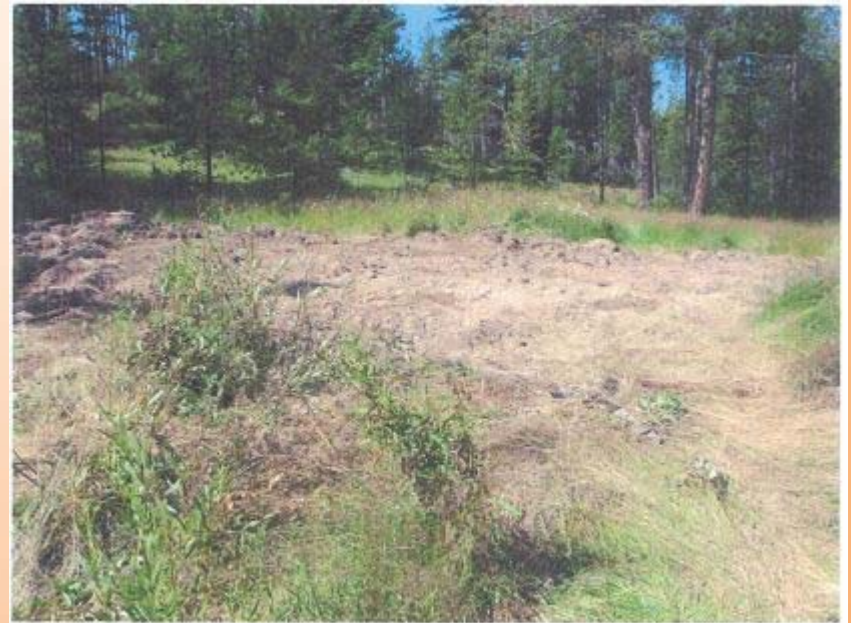
PHOTO 4

Reclaimed Bare/Tailings Areas (left) and Repository (right) (From LMRC and WET, 2003)

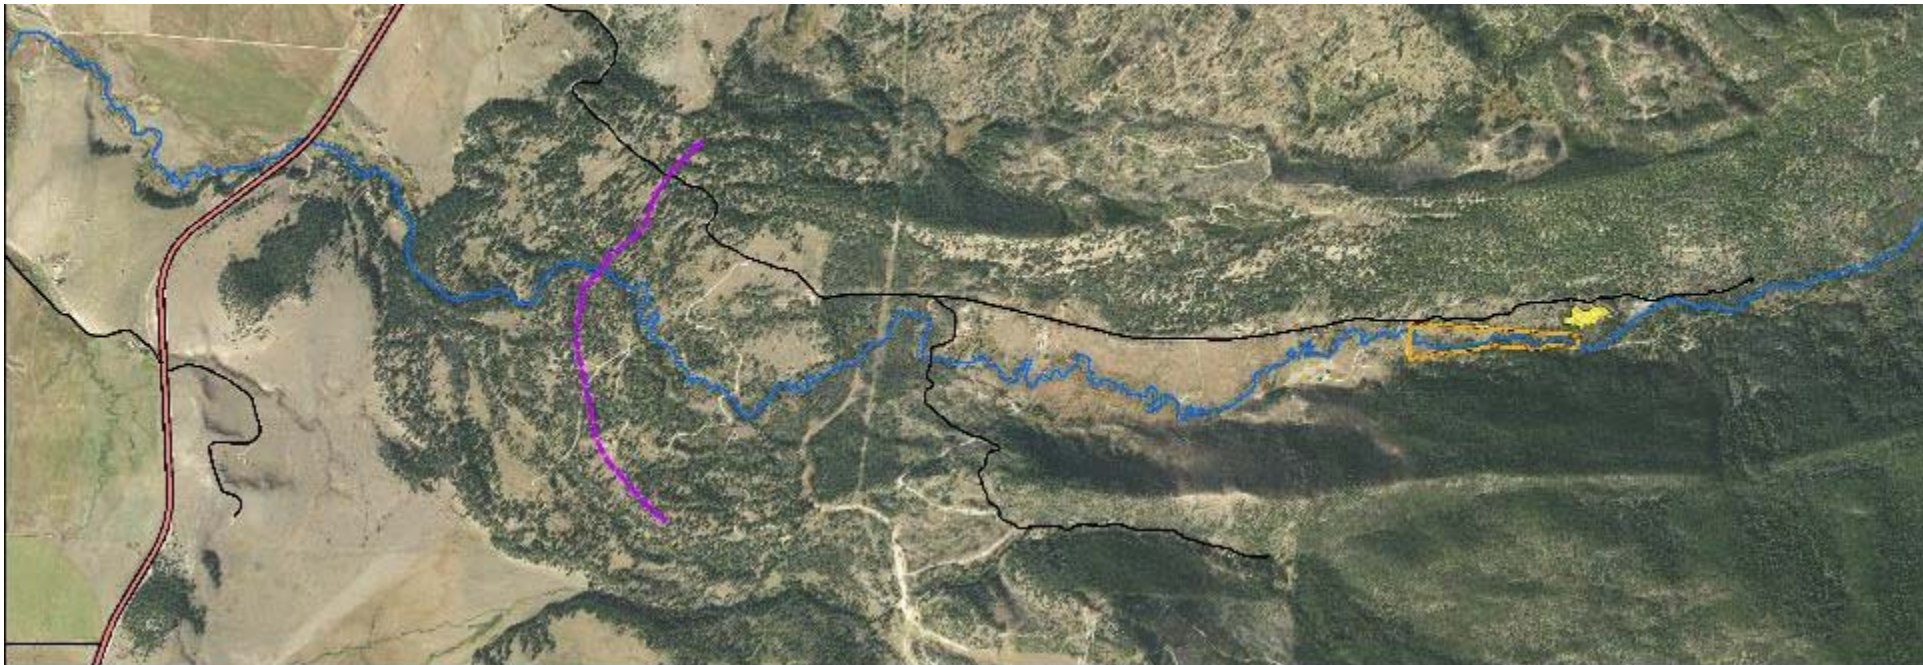
Green: Min, Avg, Max Elevation: 2208, 5629, 8448 ft
 Range Top: Distance: 7.85 mi Elev Gain/Loss: 1890 ft - 485 ft Max Slope: 63.3%, -6.4% Avg Slope: 5.4%, -2.0%

Fred Burr Creek - Rumsey Mill Site
 Elevation Profile

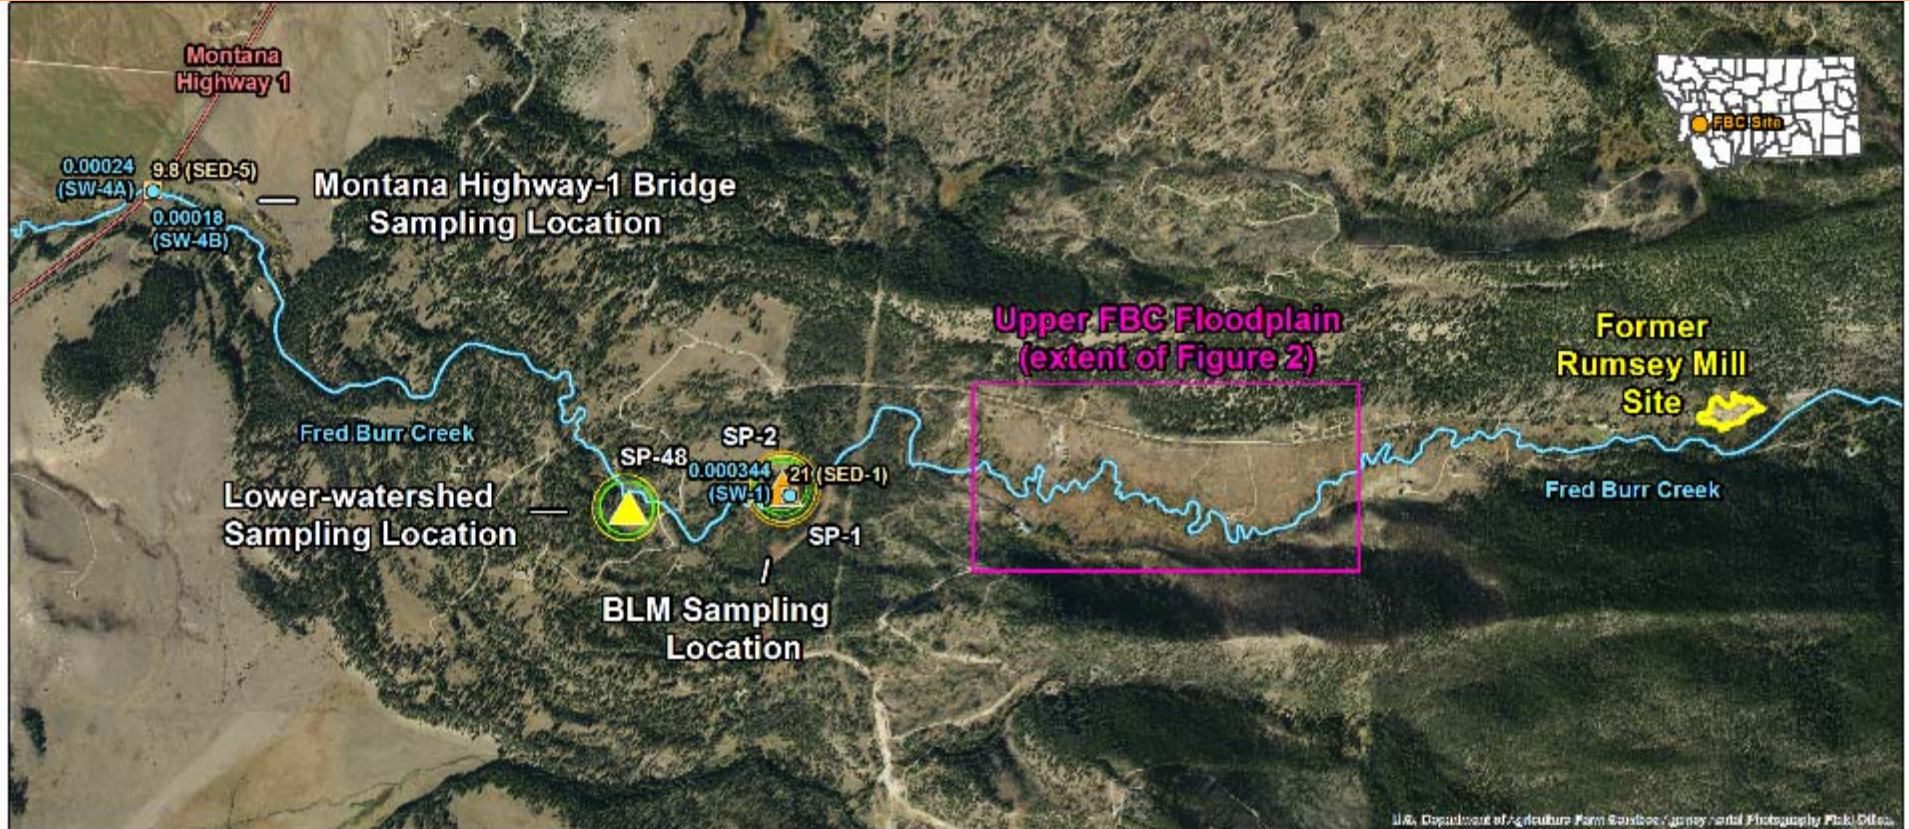
Watershed-scale site map and sampling locations for the July 2018 field investigation at Fred Burr Creek.

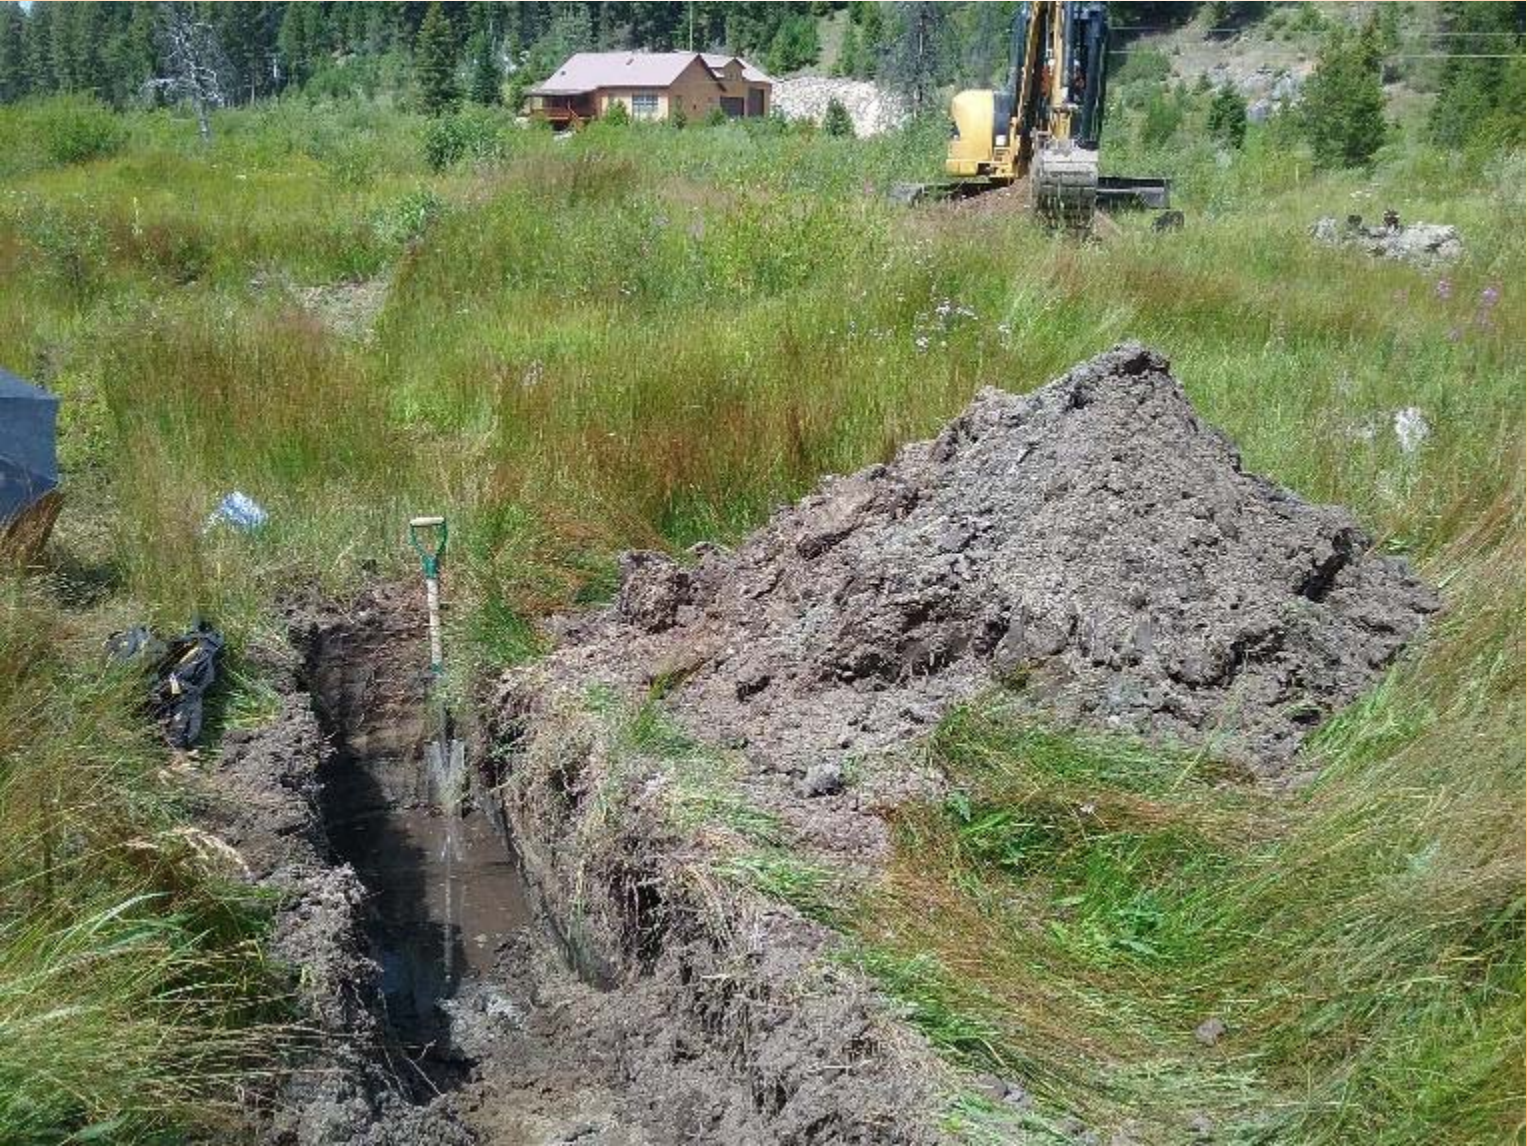
Typical excavator-dug soil pit during the July 23rd to 26th 2018 field investigation at Fred Burr Creek.

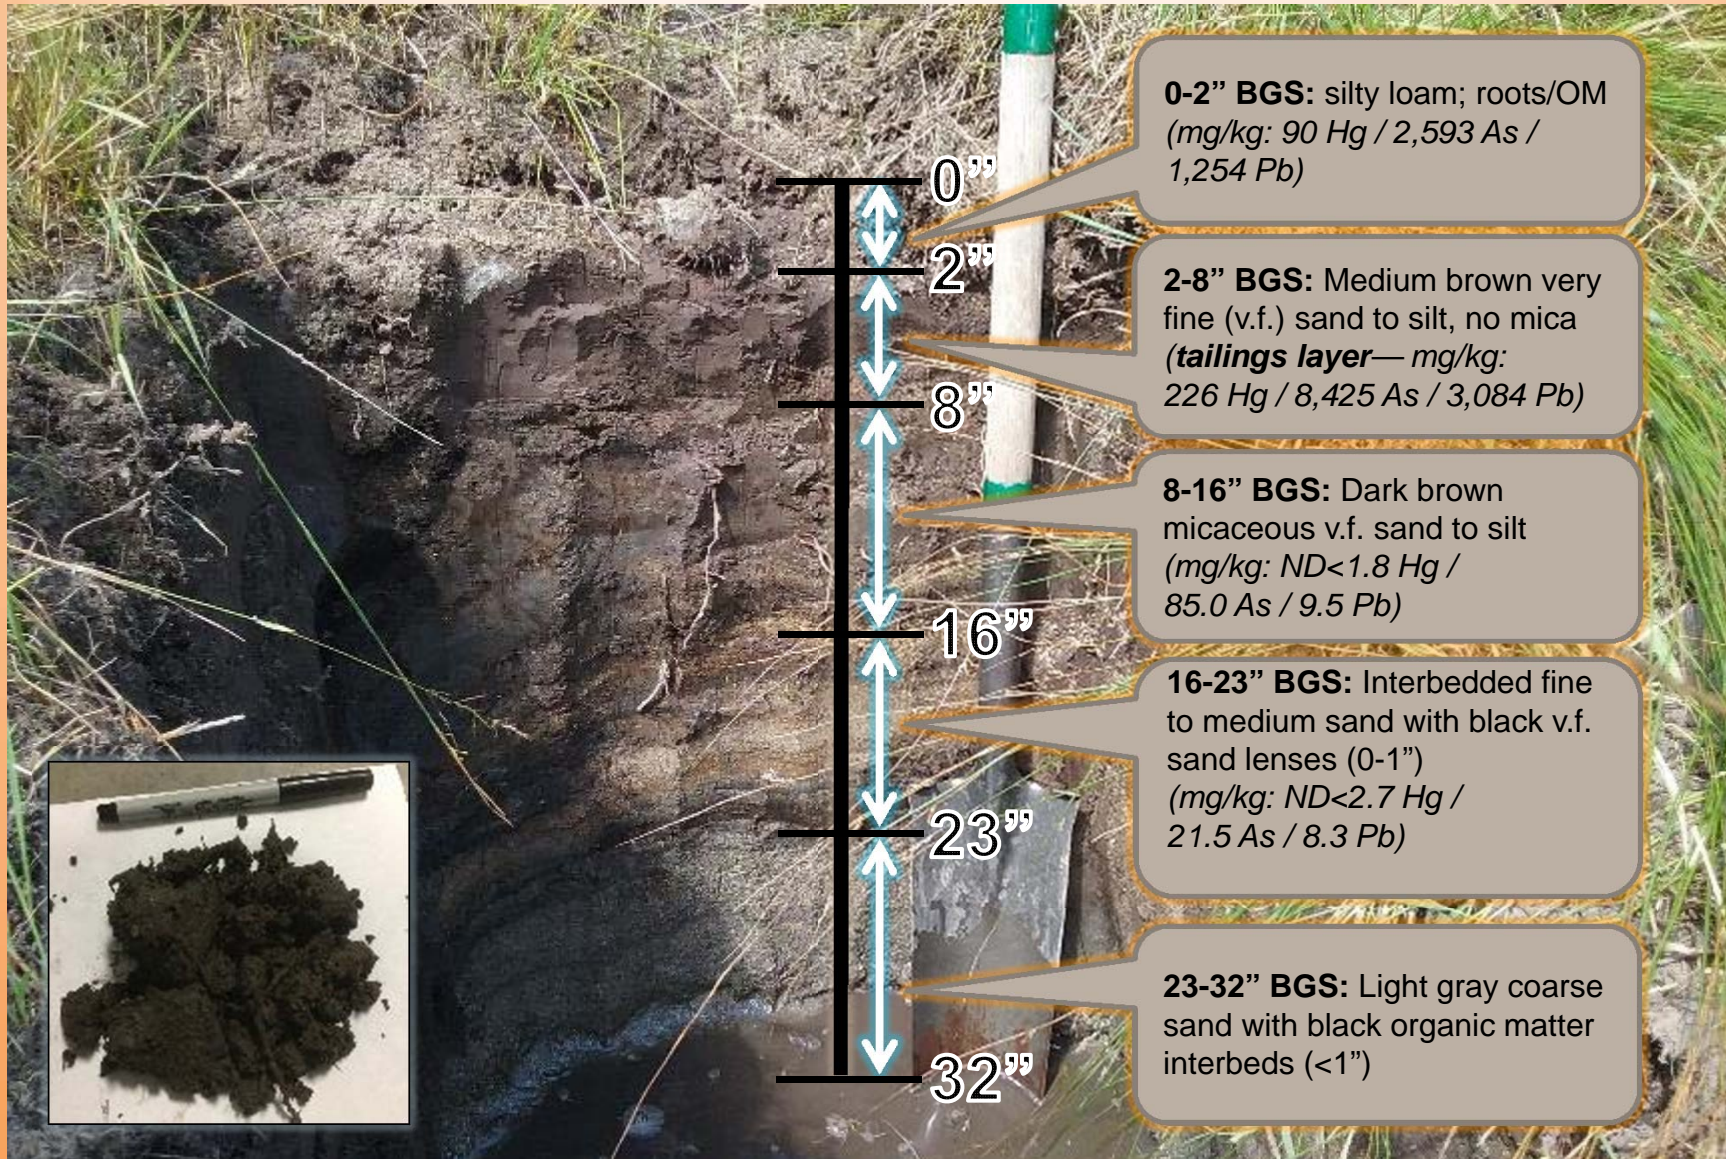
**Representative FBC soil profile and descriptions at sampling pit SP-8 (sharpshooter spade for scale).
Inset, lower left: close-up of tailings layer (2-8" BGS) found throughout FBC.**

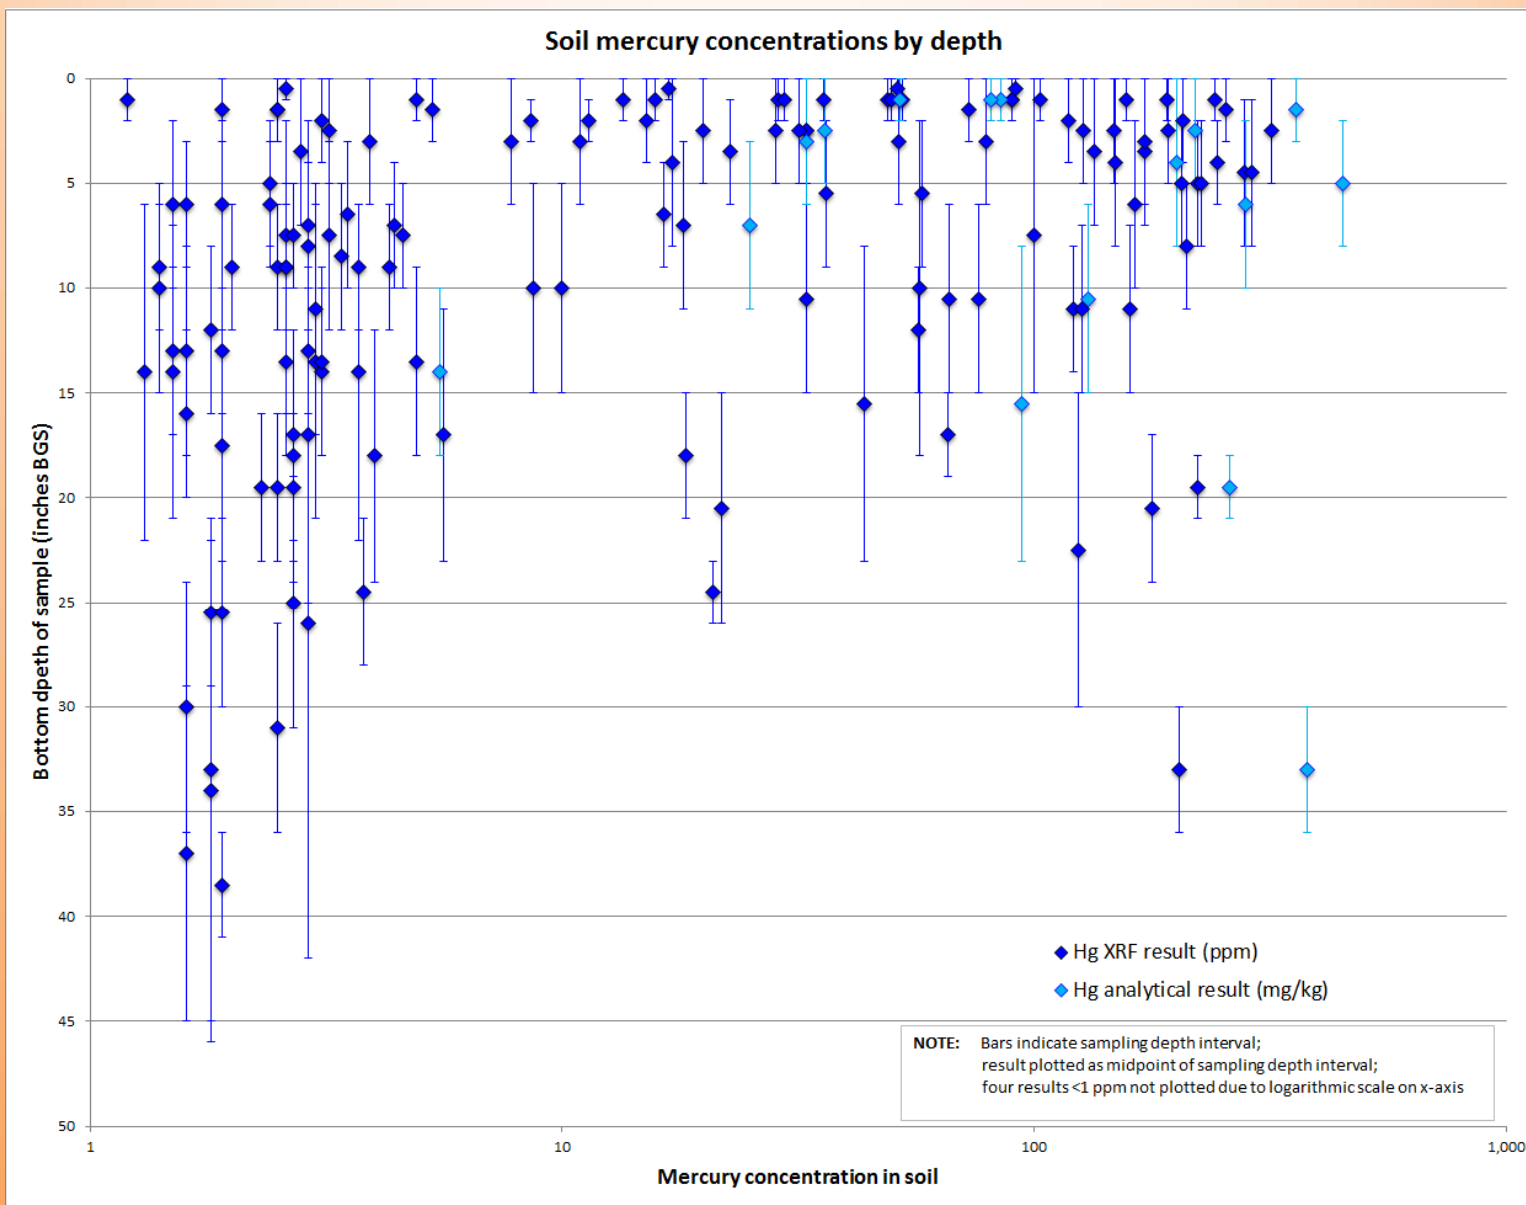
Mercury concentrations for laboratory and XRF analyses of soil samples collected in upper FBC watershed

- Mercury (Hg) and arsenic (As) are elevated, particularly in “tailings” layer
 - Mercury ranged between below detection to 450 mg/kg
 - Arsenic and lead ranged between below instrument detection and 17,100 mg/kg and 5,460, respectively

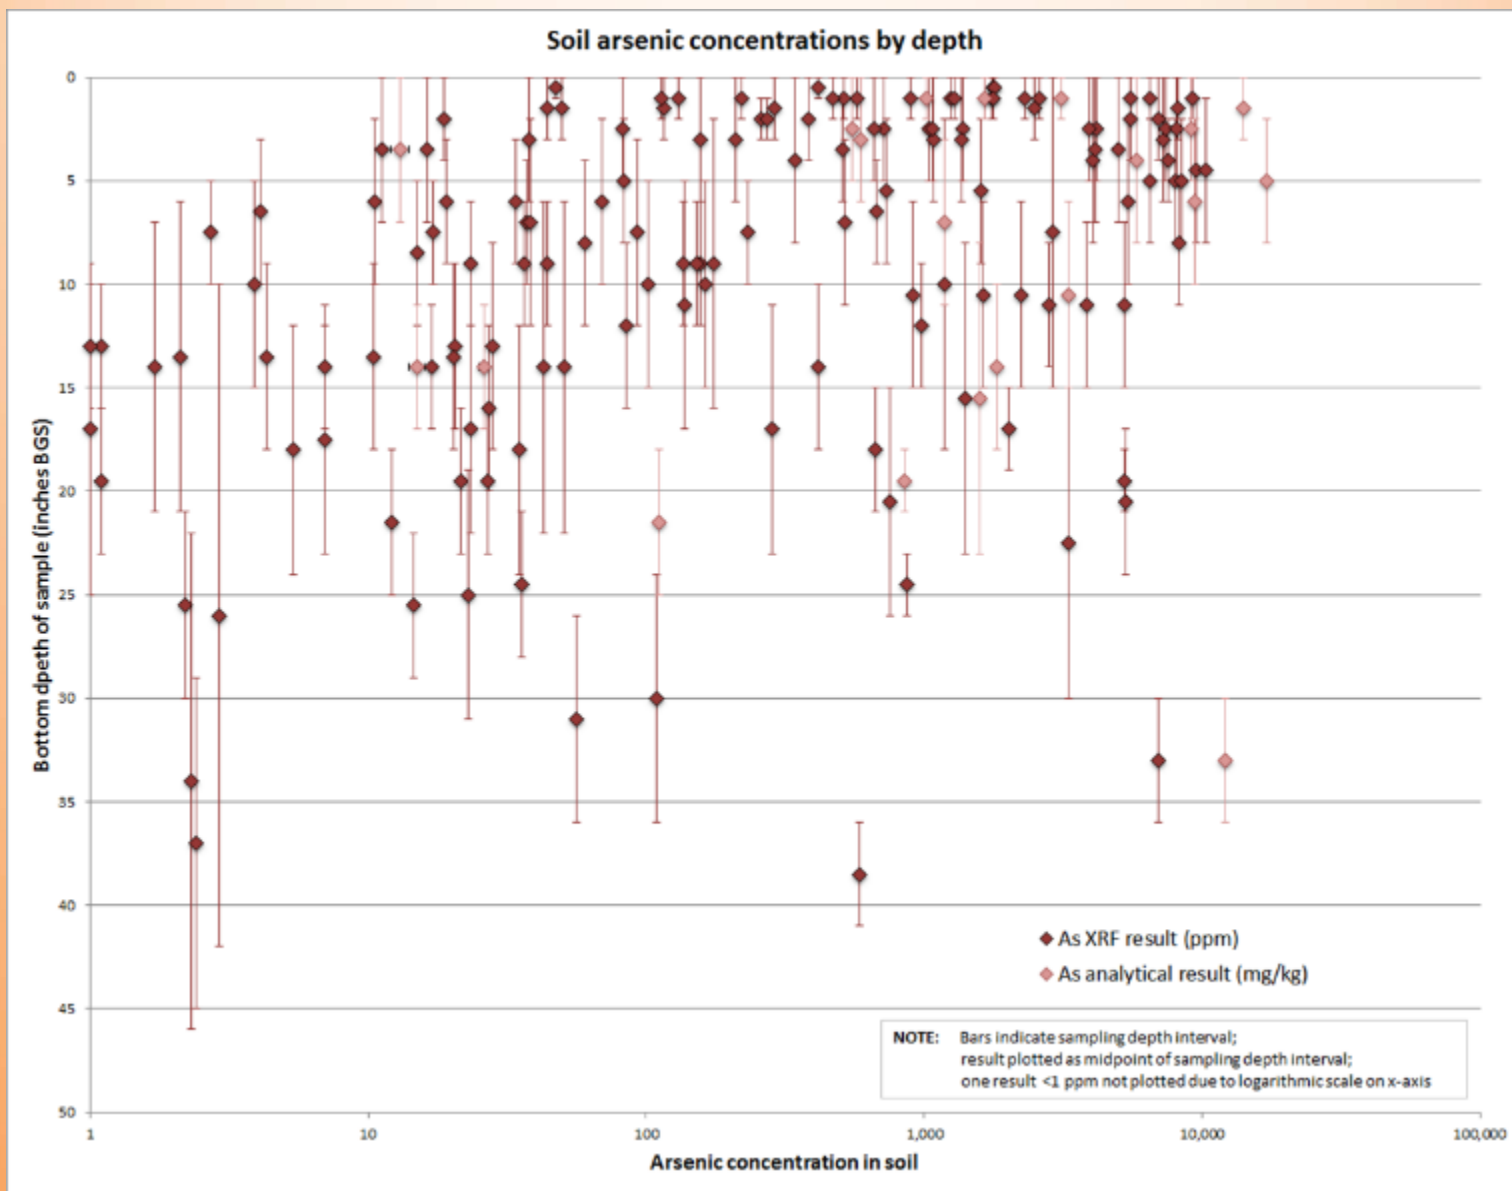
Arsenic concentrations for laboratory and XRF analyses of soil samples collected in upper FBC watershed

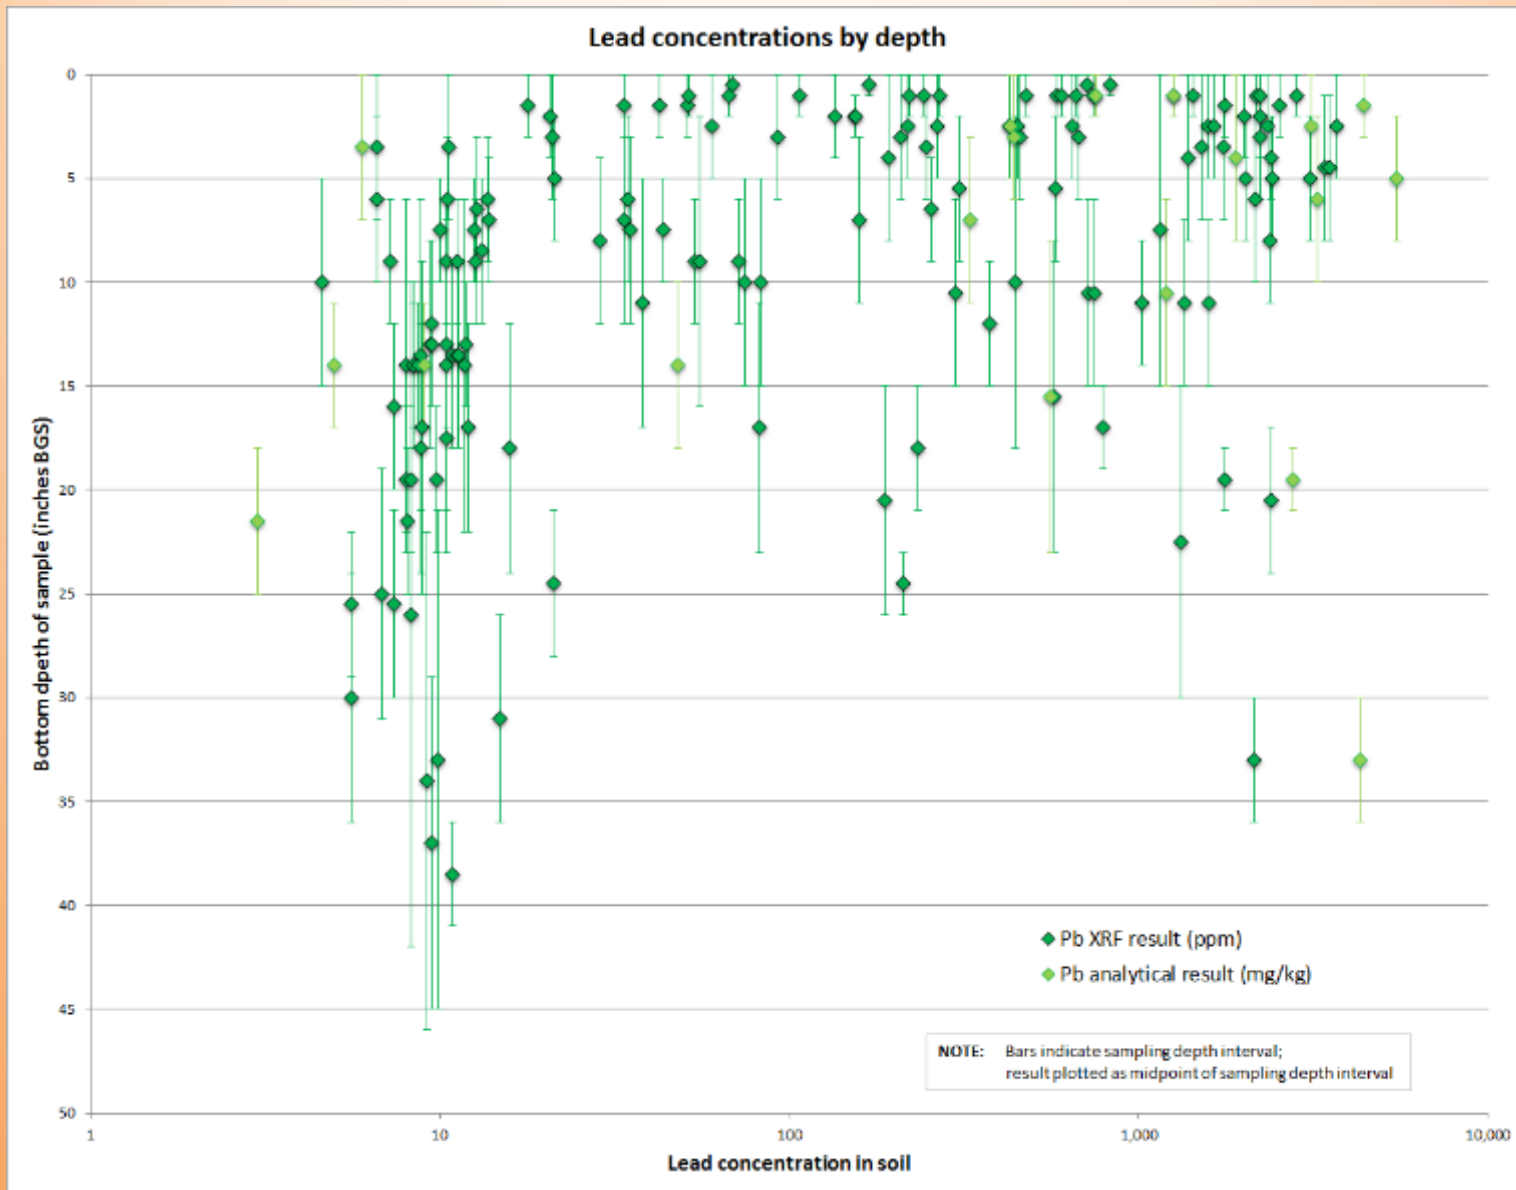
Lead concentrations for laboratory and XRF analyses of soil samples collected in upper FBC watershed

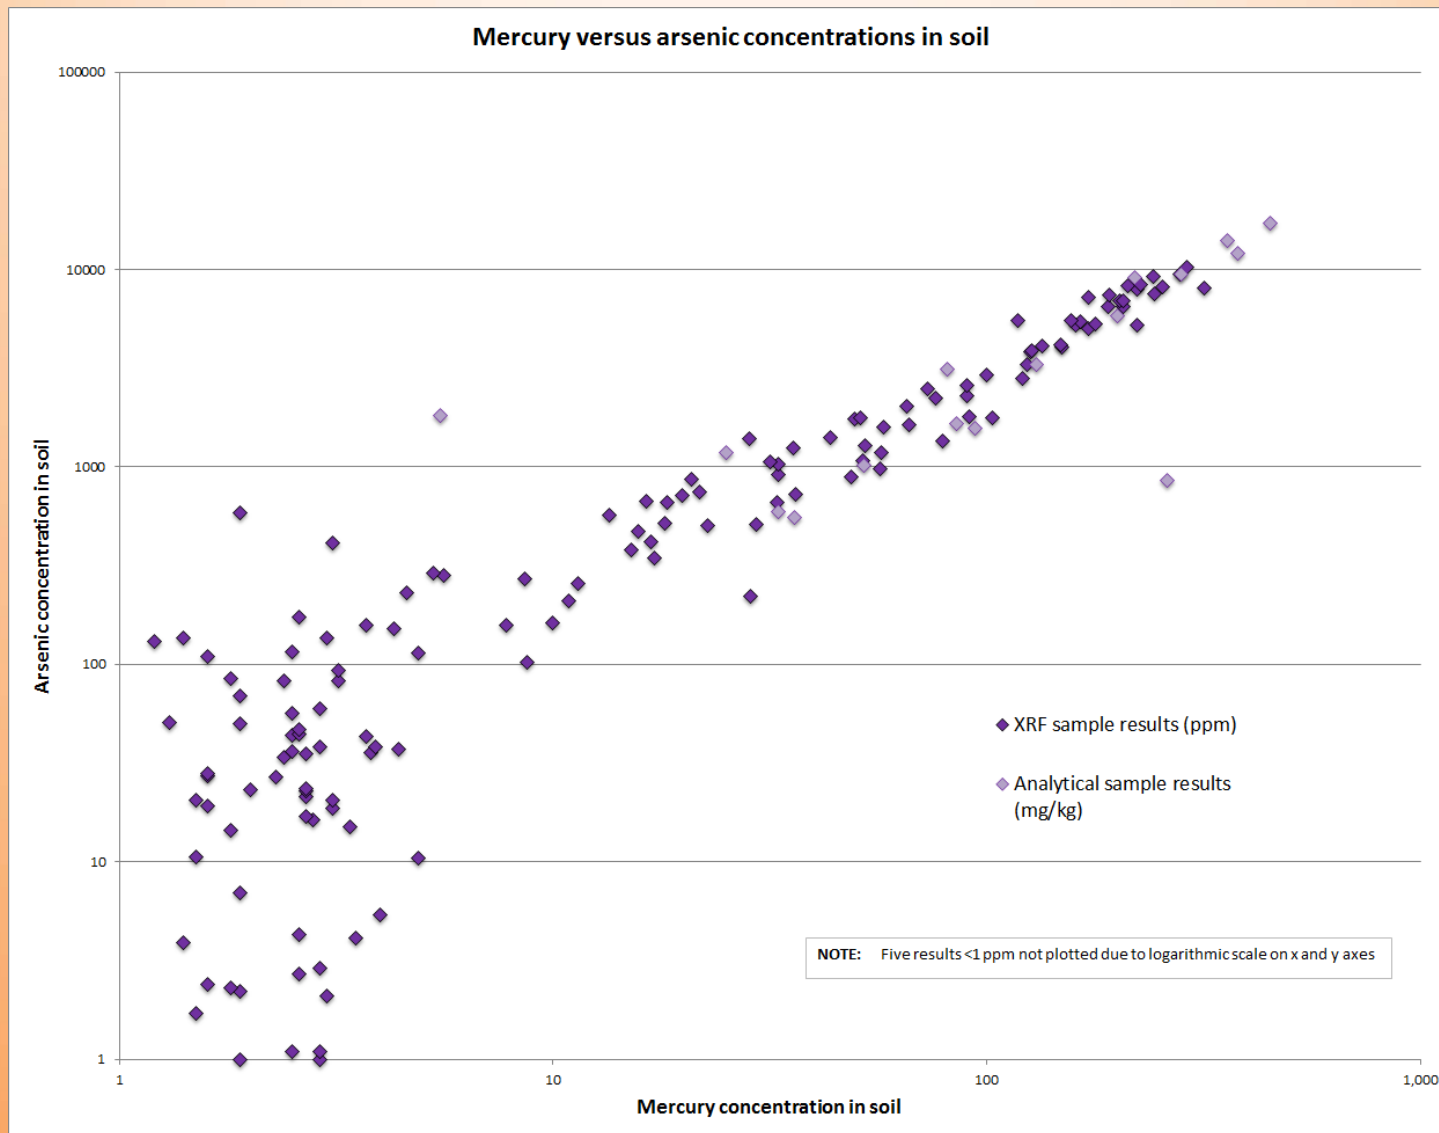
Mercury and arsenic concentrations for XRF and laboratory splits of soil samples collected in upper FBC watershed

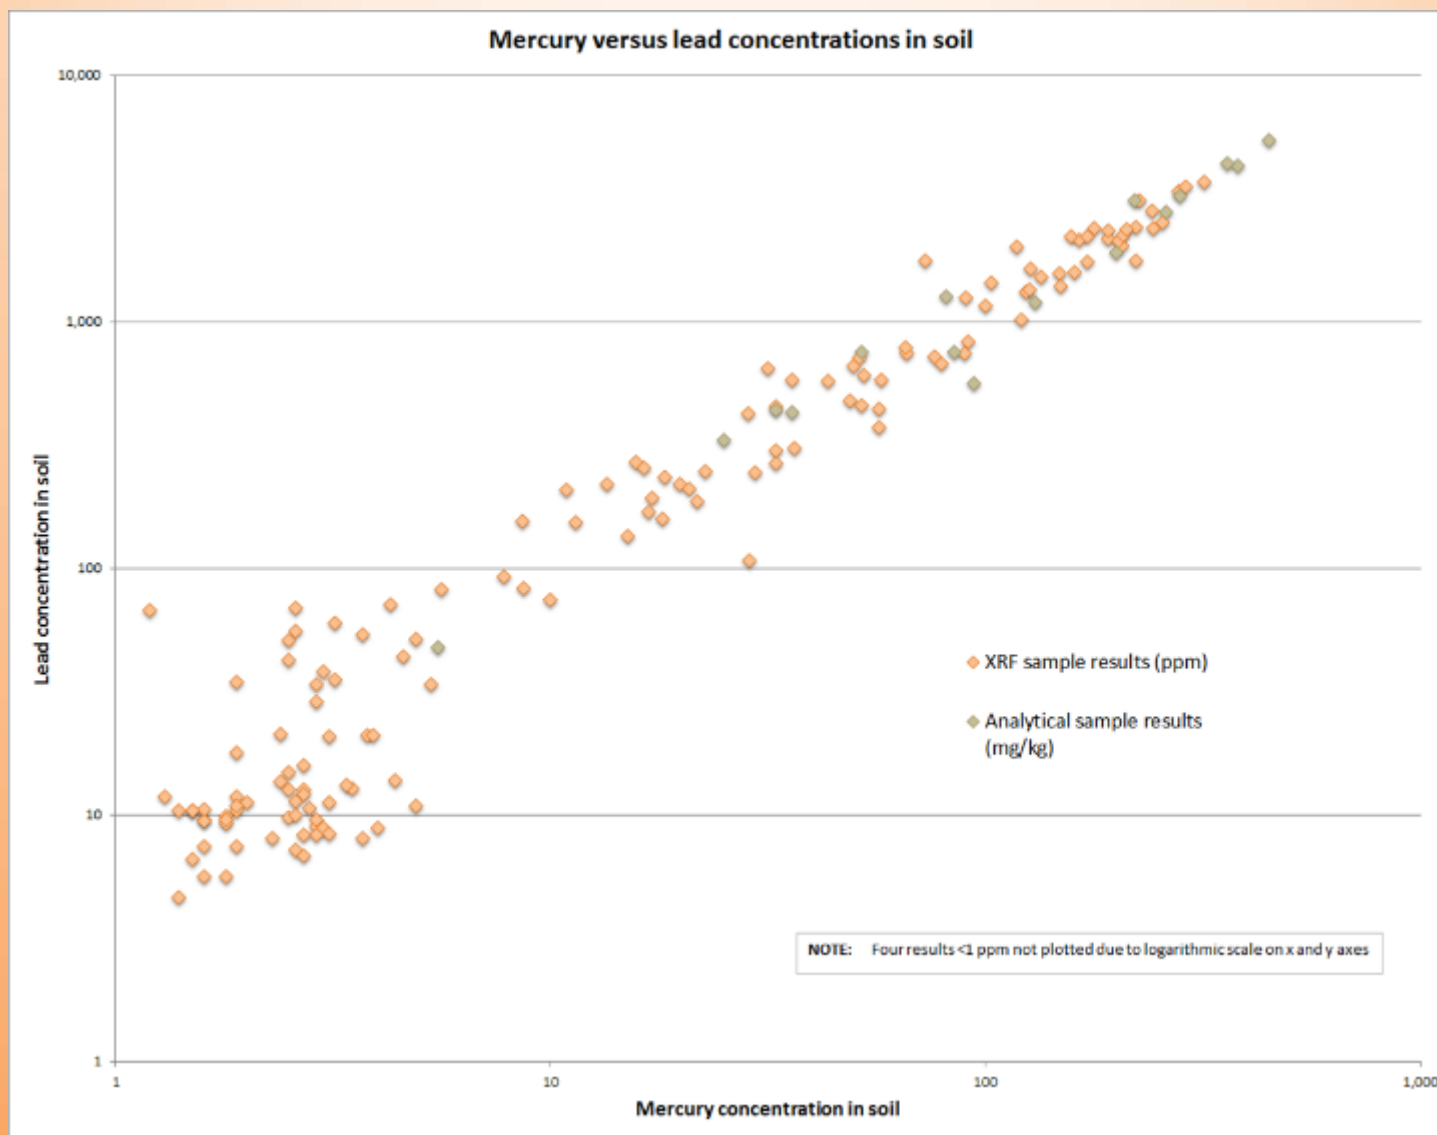
Mercury and lead concentrations for XRF and laboratory splits of soil samples collected in upper FBC watershed

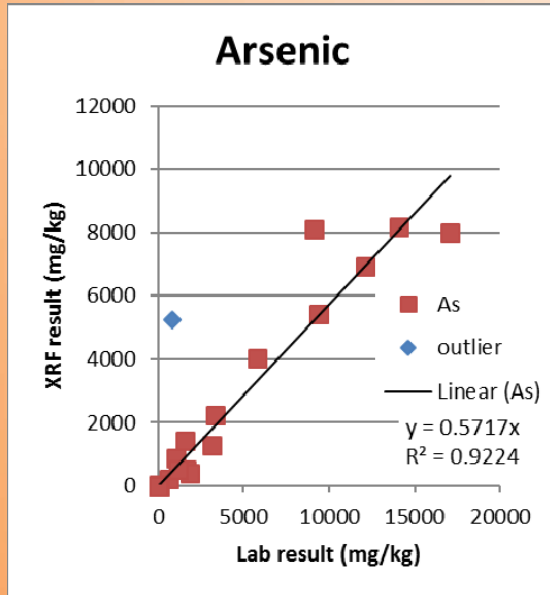
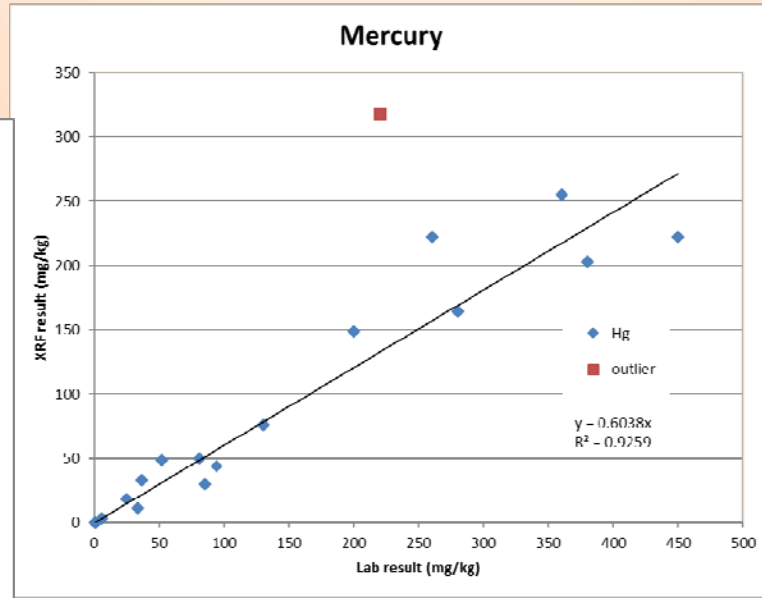
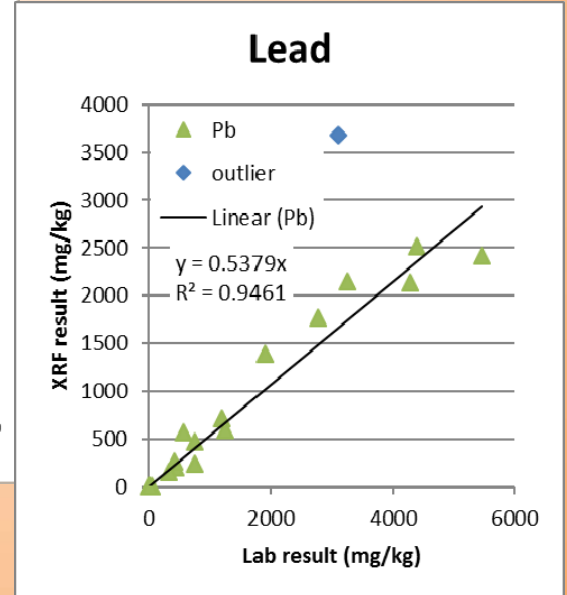
Sample Split Lab vs XRF Total Concentrations

- Impacted material ranged between approximately 0 and 25 inches BGS
 - Most impacts observed within the upper 12 to 15 inches
- Total mercury (Hg), arsenic (As) and lead (Pb) concentrations correlate strongly

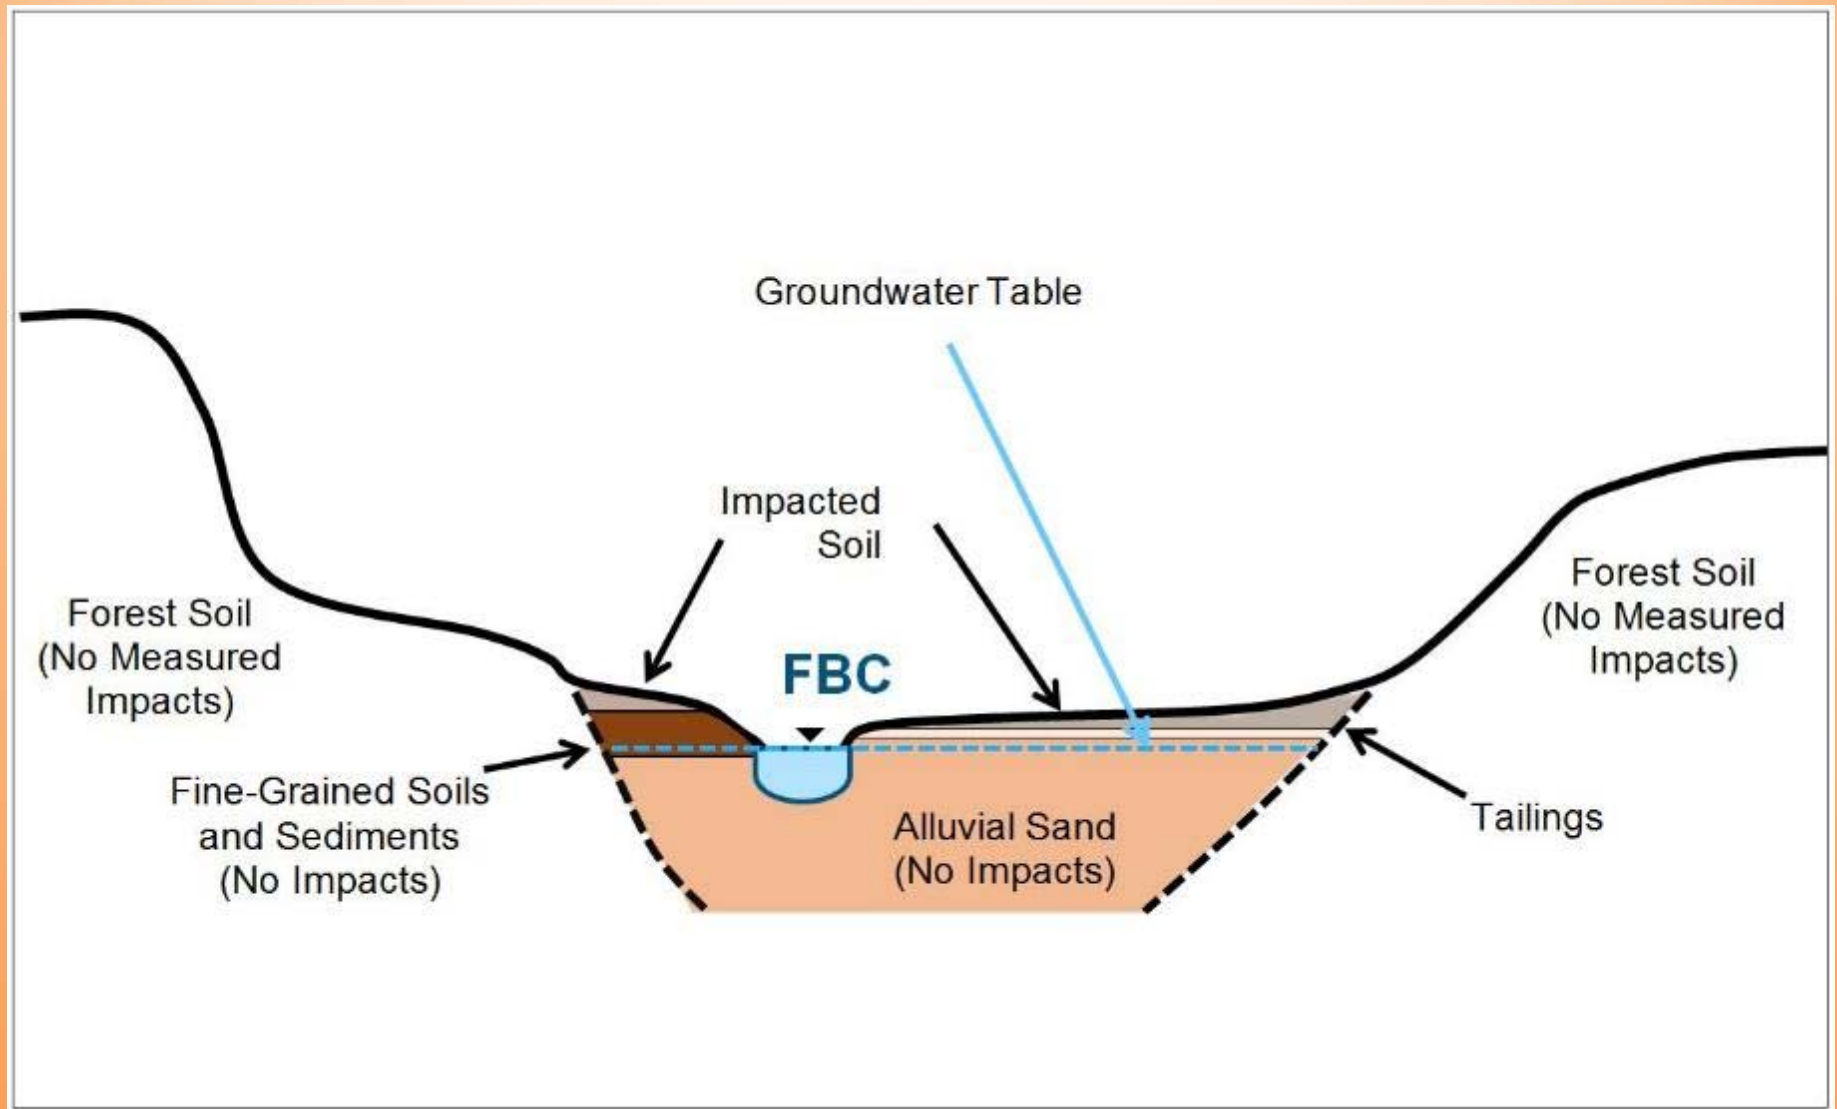
FBC floodplain cross-section schematic showing tailings, impacted, and non-impacted sediments and soils (not to scale).

- Presence of tailings/impacted soils are primarily limited to the riparian corridor and lower terraces of the floodplain (average width approximately 250 feet)

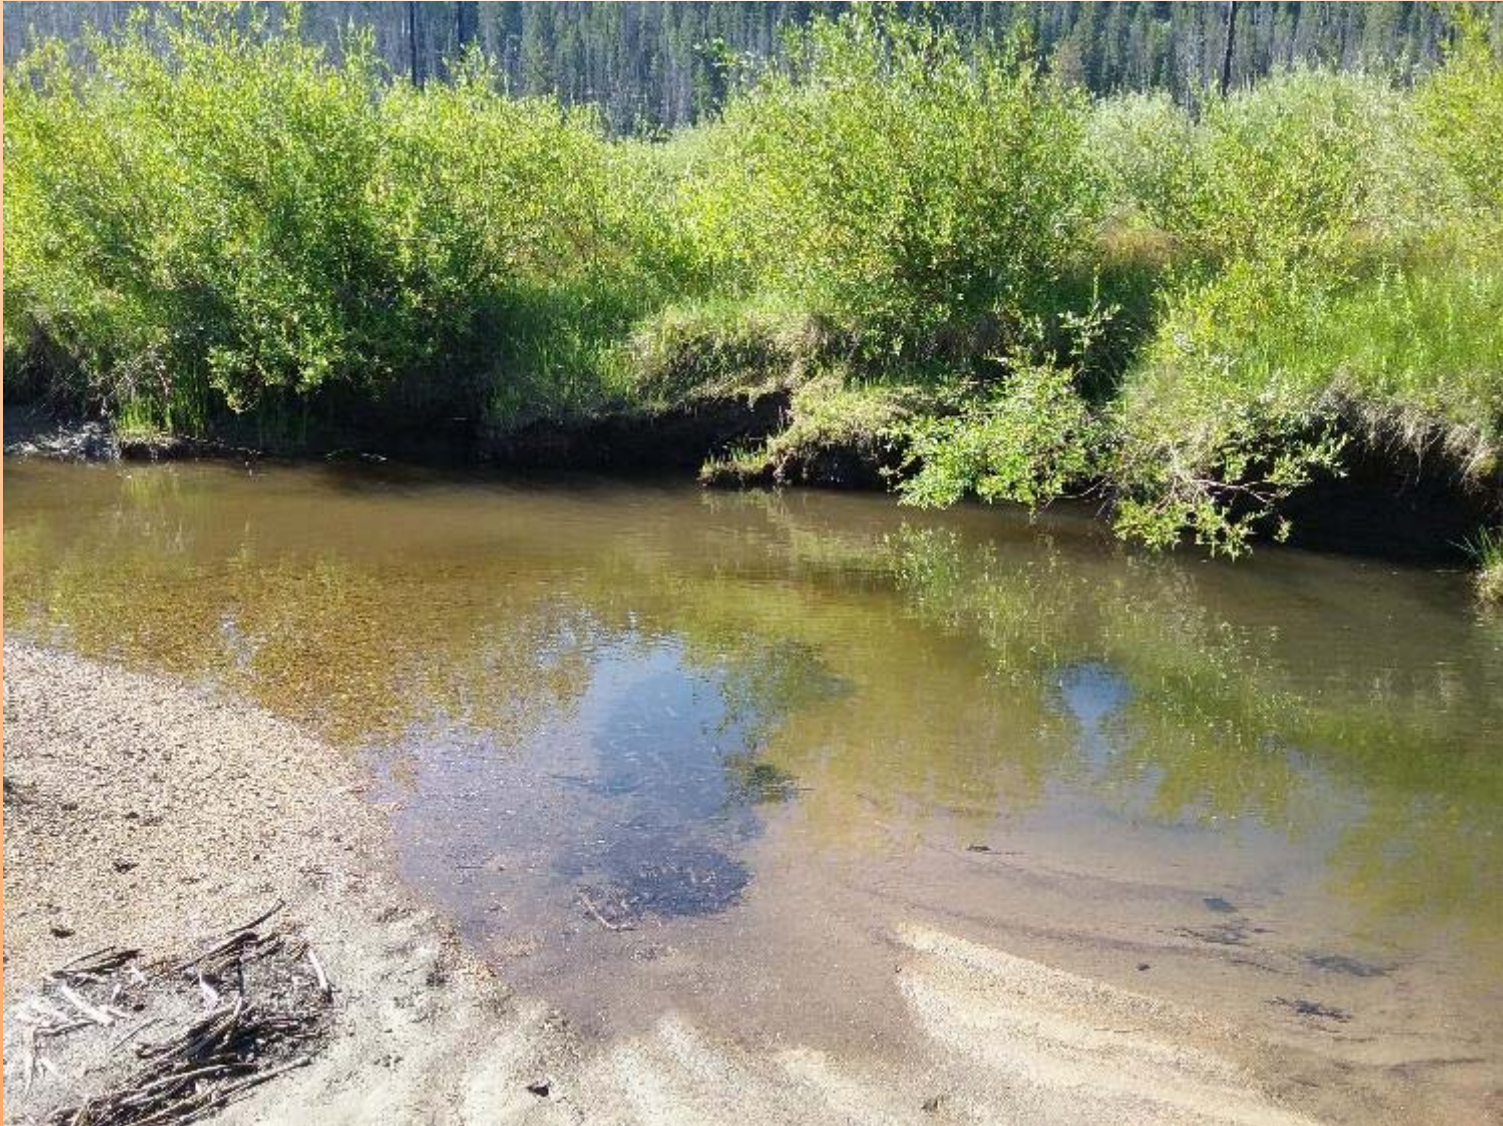
Typical sediment sample location on Fred Burr Creek

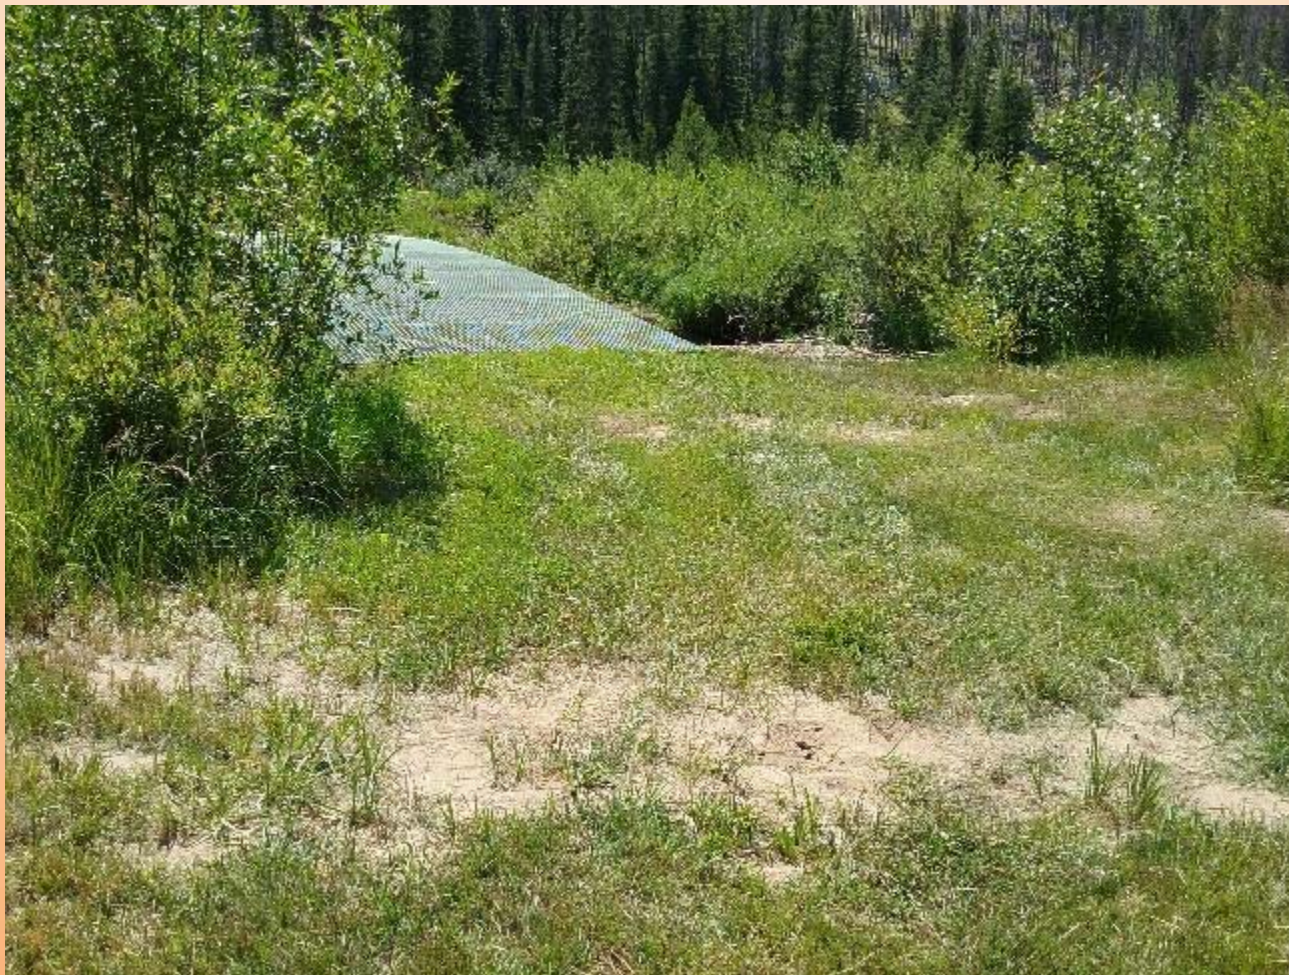
Recent (2017) flood overbank deposits on Fred Burr floodplain

- Hg, As and Pb concentrations similar in overbank deposits and stream sediment
