Rumsey Mill & Fred Burr Creek Site Characterization

Fred Burr Creek - Rumsey Mill Site
 Mercury Soil Sample Results - Detail Map

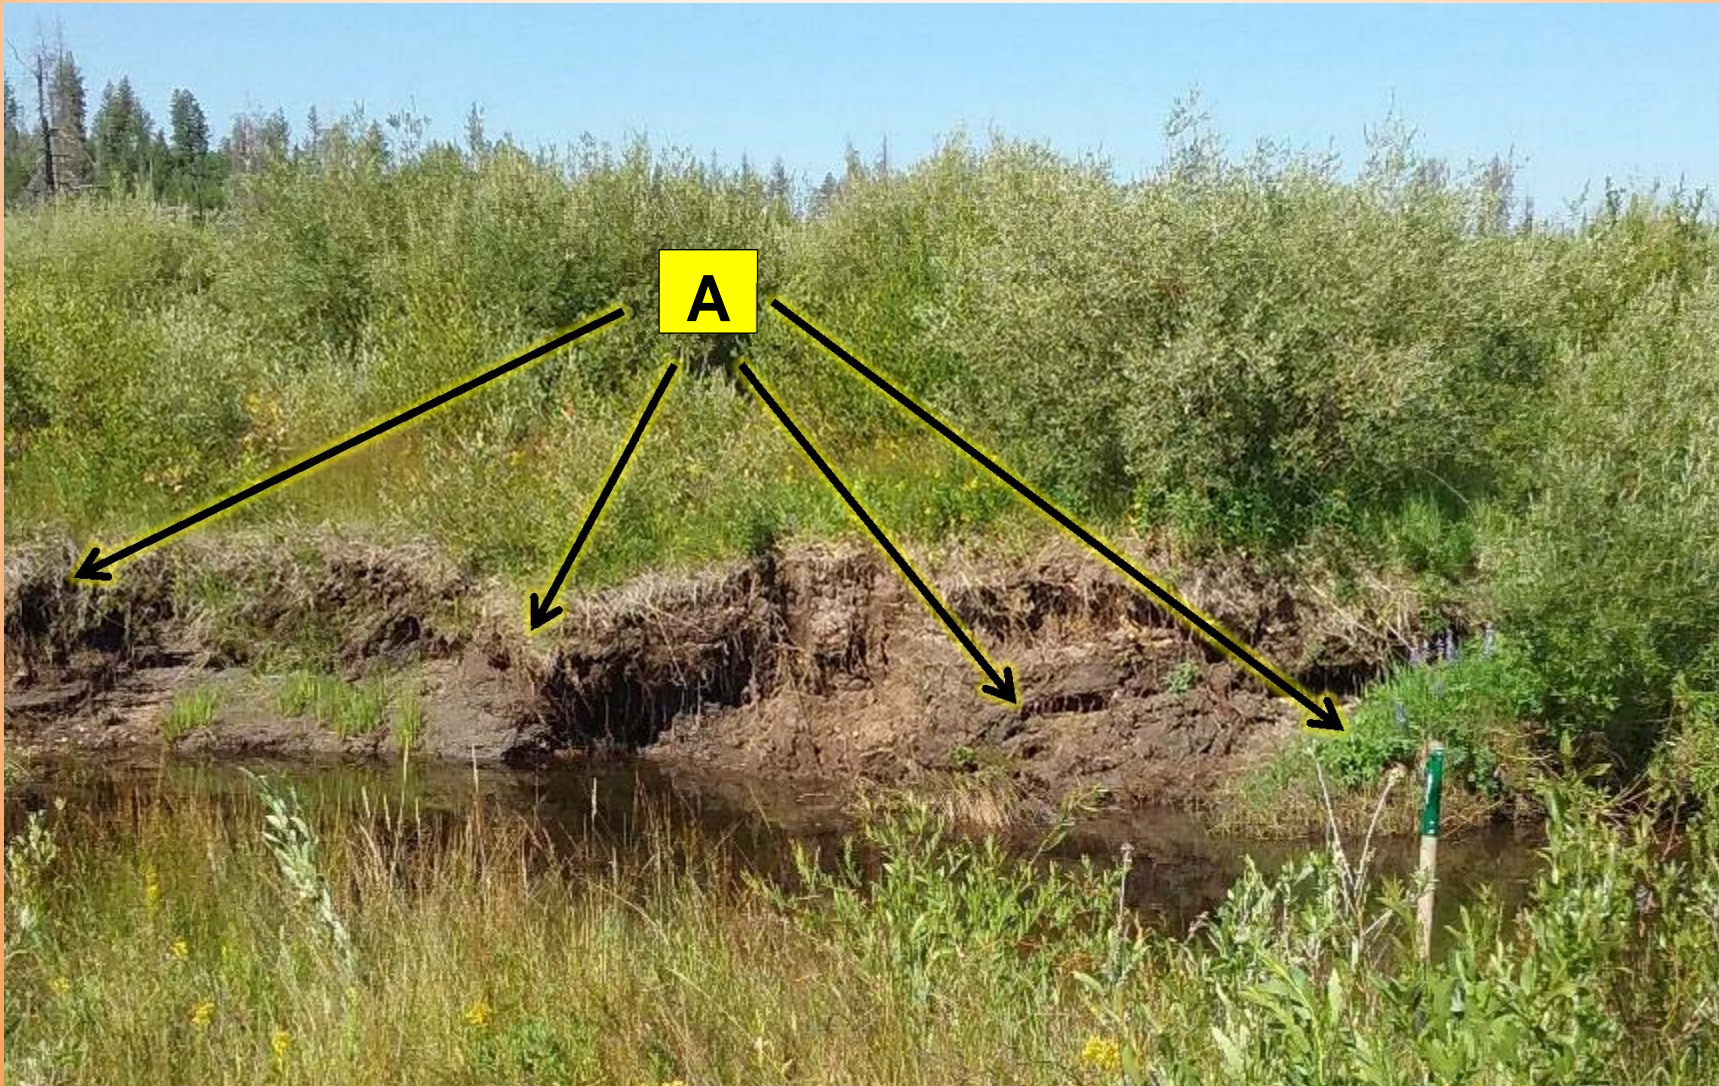
Soil (A) slumping into FBC channel as a result of streambank erosion and undercutting near SP-37. Also note red top and willows on top of the river bank—the vegetation assemblage observed with tailings impacts in the FBC floodplain.

- Determine nature and extent of contamination at mill site
- Any new information should contribute to a remediation plan and/or assessment of risk
 - Volume of impacted material in FBC floodplain/mill site
 - Estimate of streambank erosion rates
 - Groundwater pathway
 - Concentration of metals in vegetation
 - Methylmercury impacts
- Risk assessment
 - Human Health and Ecological
 - Based on contaminant exposure pathway and receptor
