**SEALED WELL**  
**A New Approach to Assessing  
& Remediating Annular Gas**

**BioSqueeze**  
SEALED WELL

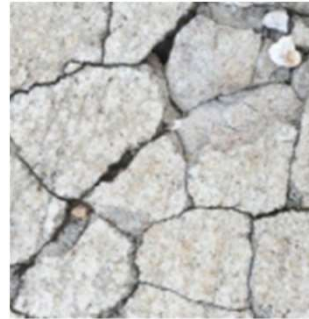
01

*Cracks Form and  
Leak Methane*

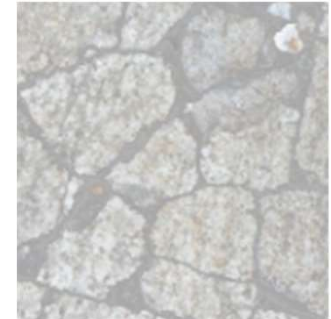
03

*Impermeable  
Seal Created*
