CLOSURE OF THE KINROSS DELAMAR MINE

Steve Smith – Environmental Manager – Reclamation Operations (ROBU)

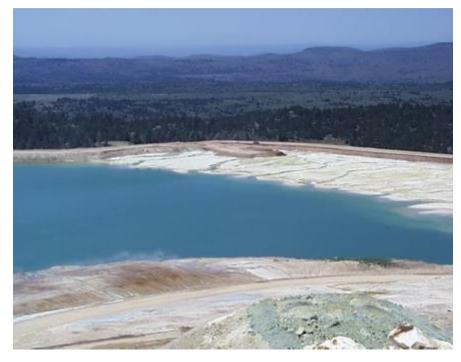
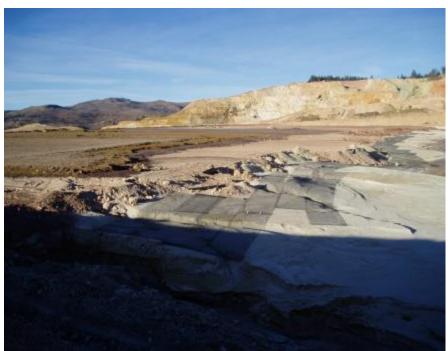
TAILINGS POND CLOSURE -- 2003-2014

- Very challenging circumstances; limited treat and discharge options
- 200-acre tailings surface
- Set aggressive schedule to retain agency support
- 4-layer cover; foundation, compacted clay, subsoil, soil; approx 8 ft total

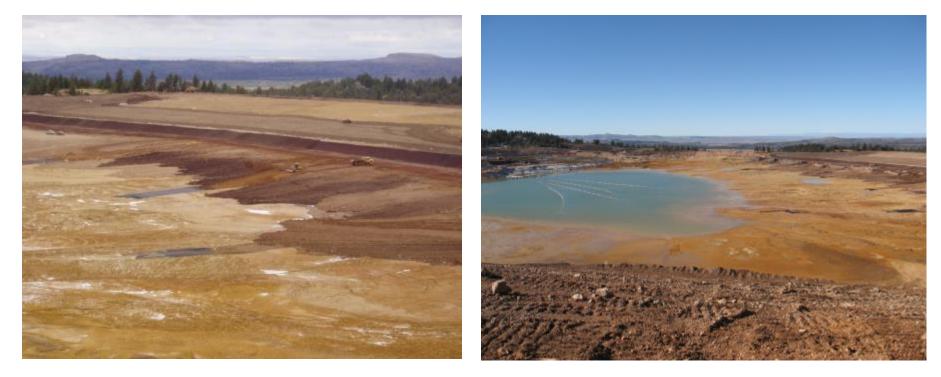
- Continue cover advancement
- Transition to LGP and geo-grid/geo-textile reinforced haul routes
- De-watering ACCELERATED due to reduced ARD flows to be stored
- Storm water diversion adjacent and on reclaimed areas

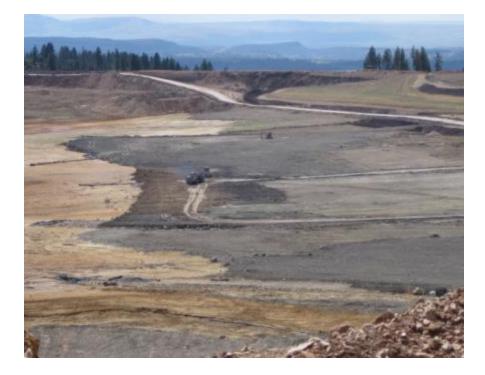
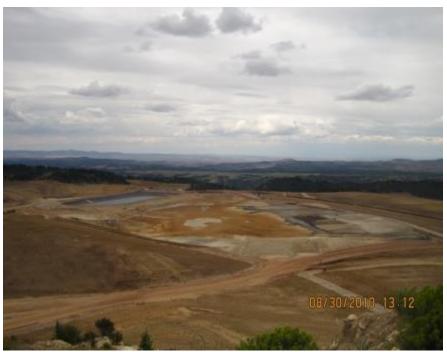
- Continue cover advance with typical LGP D5 and 35 ton trucks
- Tailings surface essentially de-watered
- Increased management required for pore water and seeps

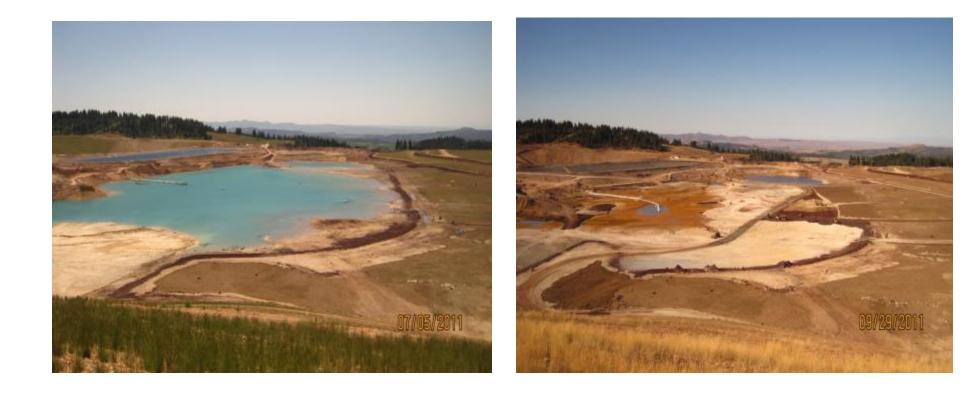
- Heavy snowpack and heavy spring rains
- Early season de-watering challenges
- Late season very successful

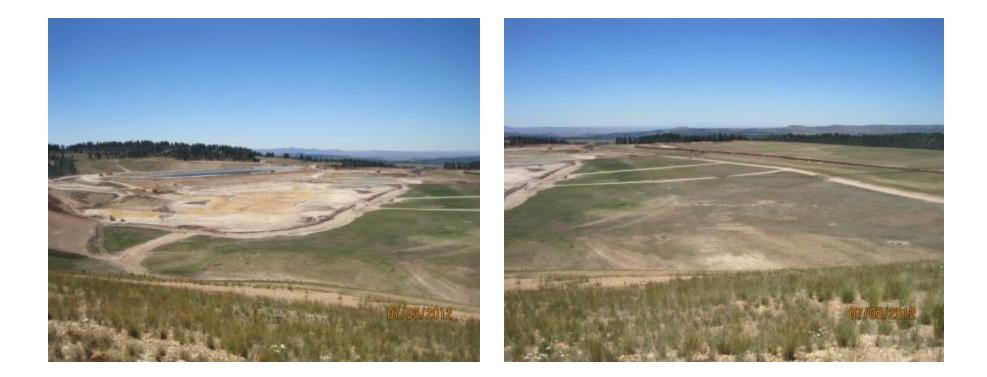
- Normal spring weather patterns
- Previous year tailings drying and consolidation improve working conditions
- Successful construction season

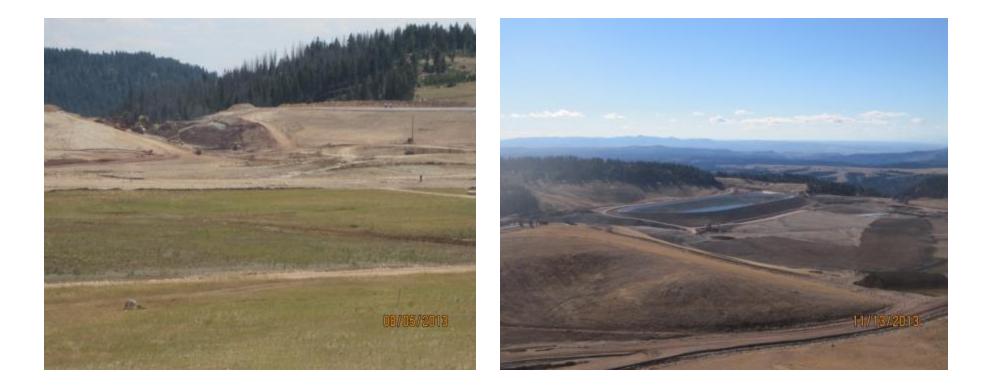
- Cover essentially complete, some localized areas and topsoil remaining
- Spillway excavation essentially complete and functional
- Variety of smaller projects in 2014 to finish earthworks
