AZURITE MINE - CERCLA REMOVAL ACTION PROJECT

**2011 – Mine Design, Operation, & Closure Conference
Dustin G. Wasley, PE, Principal
Cascade Earth Sciences
May 3, 2011**

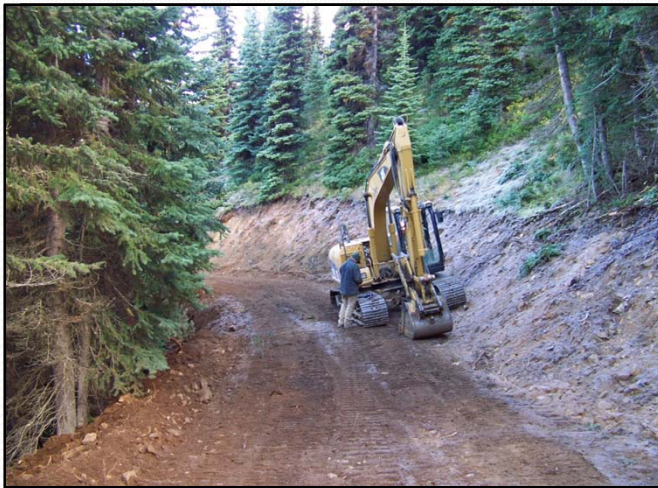
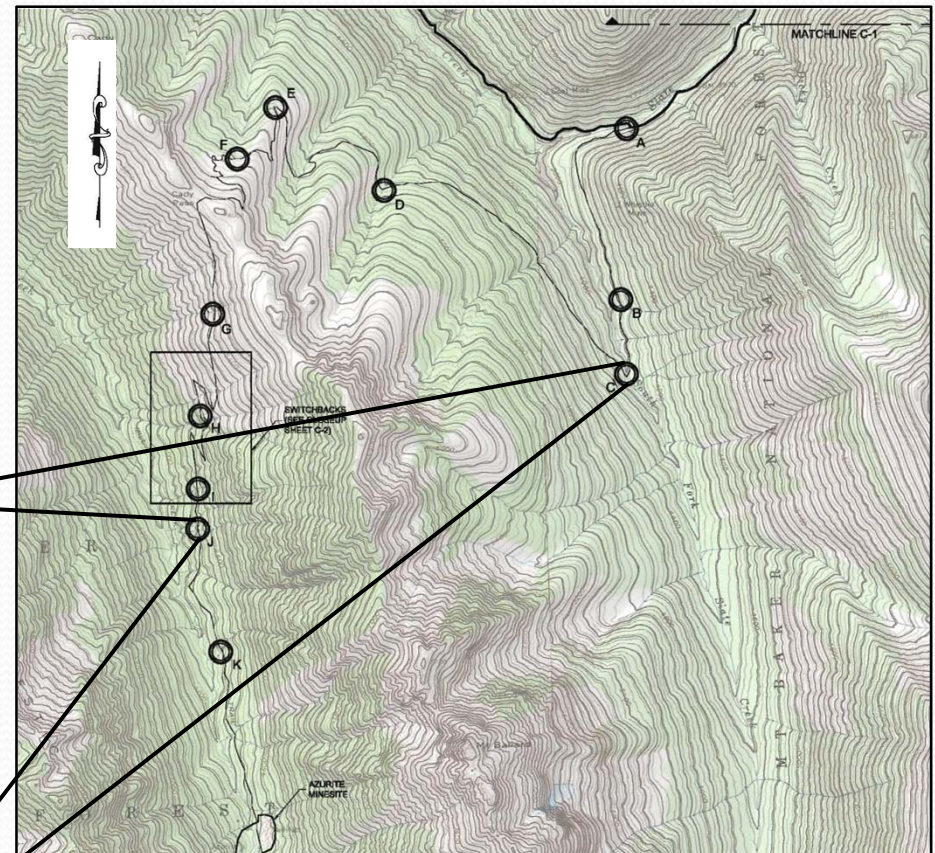
Access Road Improvements (Complete)

- Work in 2010 by Palm Construction/USFS
- Bridge Installation
- Road Widening/Grading
- Switchback Improvements
- Culvert Installation

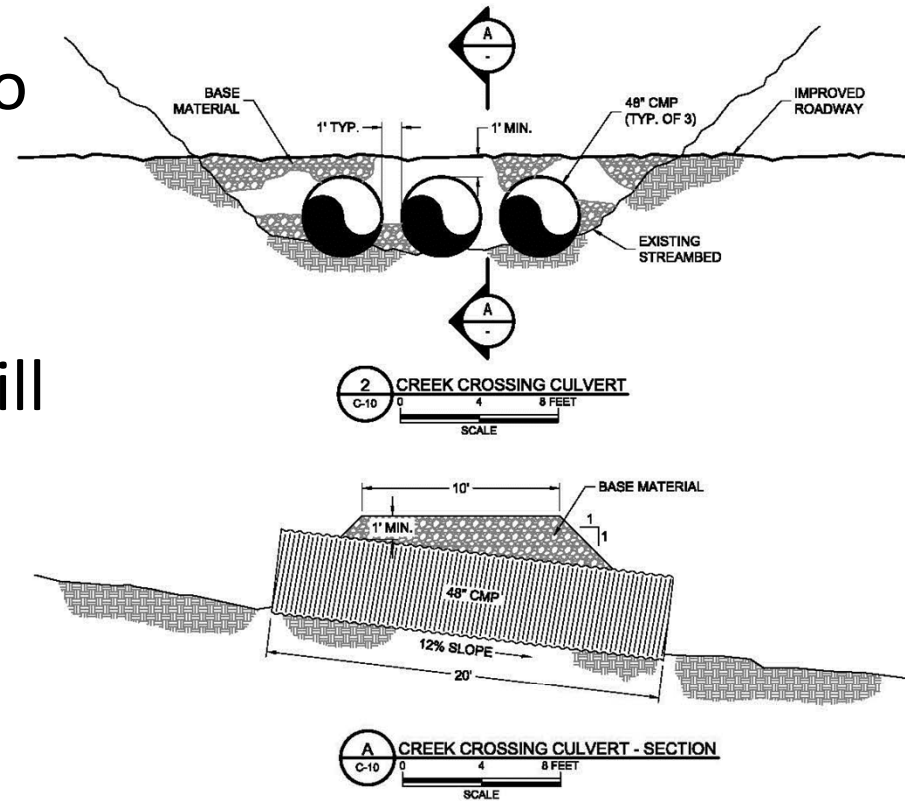
Temp Access Road Across Mill Creek

- Needed to Access Waste Rock Pile, and Transport to Repository
- Three, 48-inch CMPs
- Will Temporarily Divert Mill Creek Away From Waste Rock Pile
- Time Dependent on Mill Creek Flow Rate

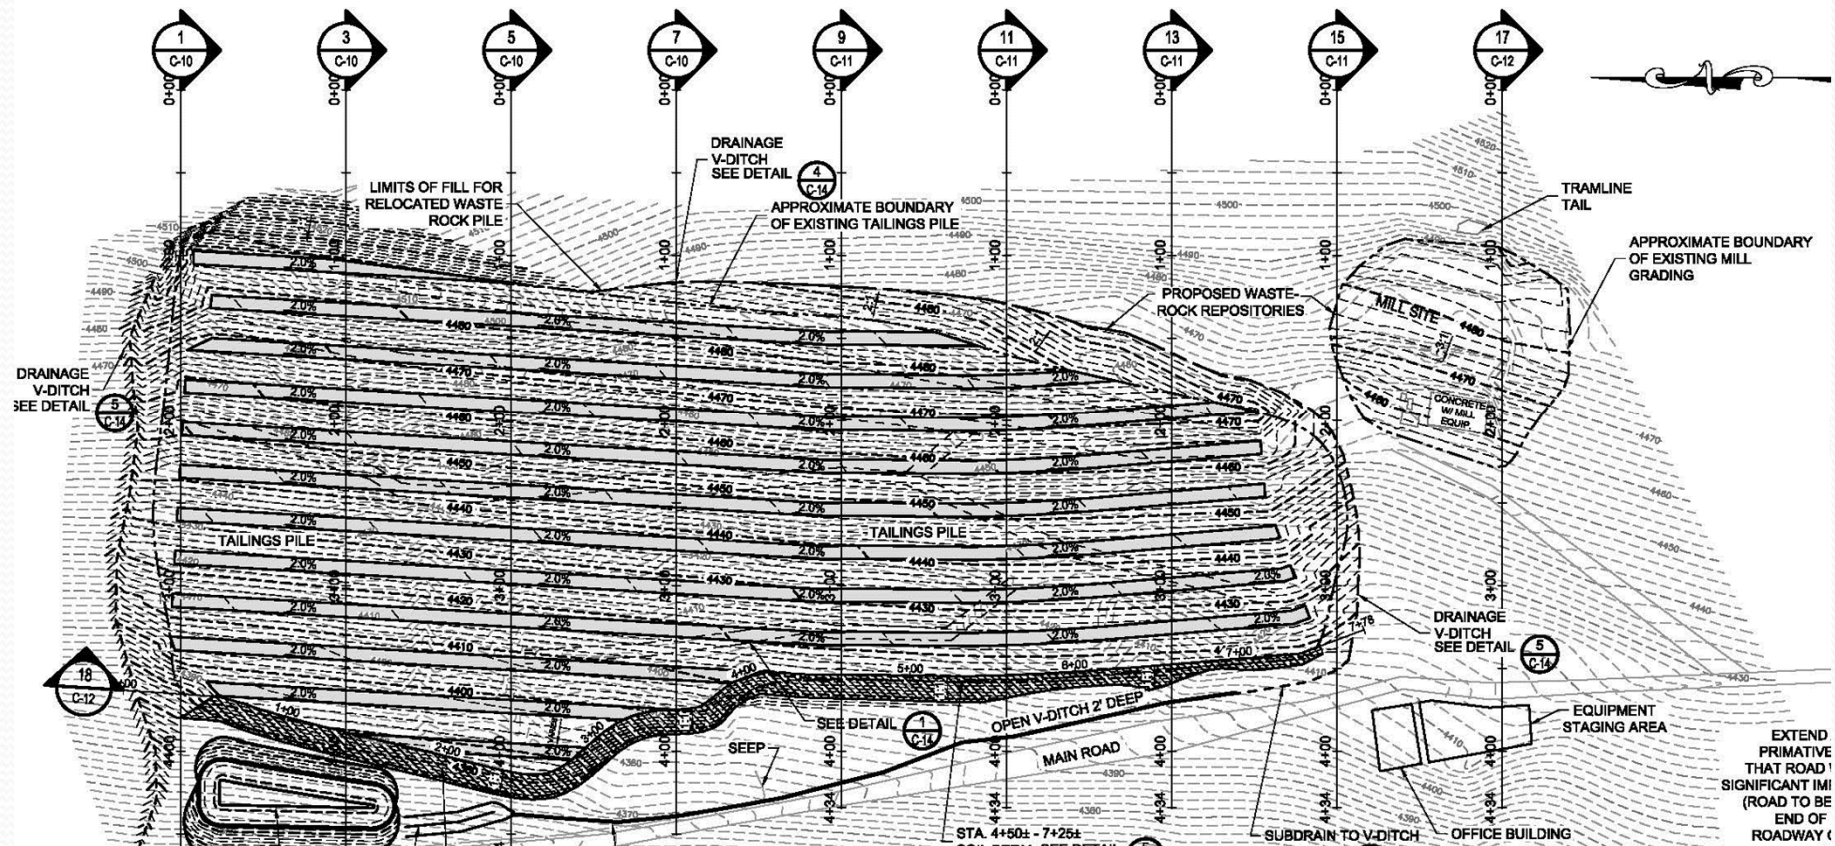
Repository Grading Plan

- Overall Slope 2.5:1
- Waste Rock Placed & Blended w/ Tailings to achieve slope
- In-sloped benches every 20-25 feet to relieve precip
- Reinforced Stabilized Slope/Toe Berm
- Repository Cover (multi-layer system)
 1. Talus/Rock Cover
 2. Geogrid
 3. 12-oz Nonwoven Geotextile
 4. 40-mil HDPE Membrane
 5. 12-oz Nonwoven Geotextile
 6. Waste Rock/Tailings
