**MONTANA DEPARTMENT OF ENVIRONMENTAL QUALITY**

# **Bald Butte and Great Divide**

## **Reclamation Project**

**Lewis and Clark County, Montana**

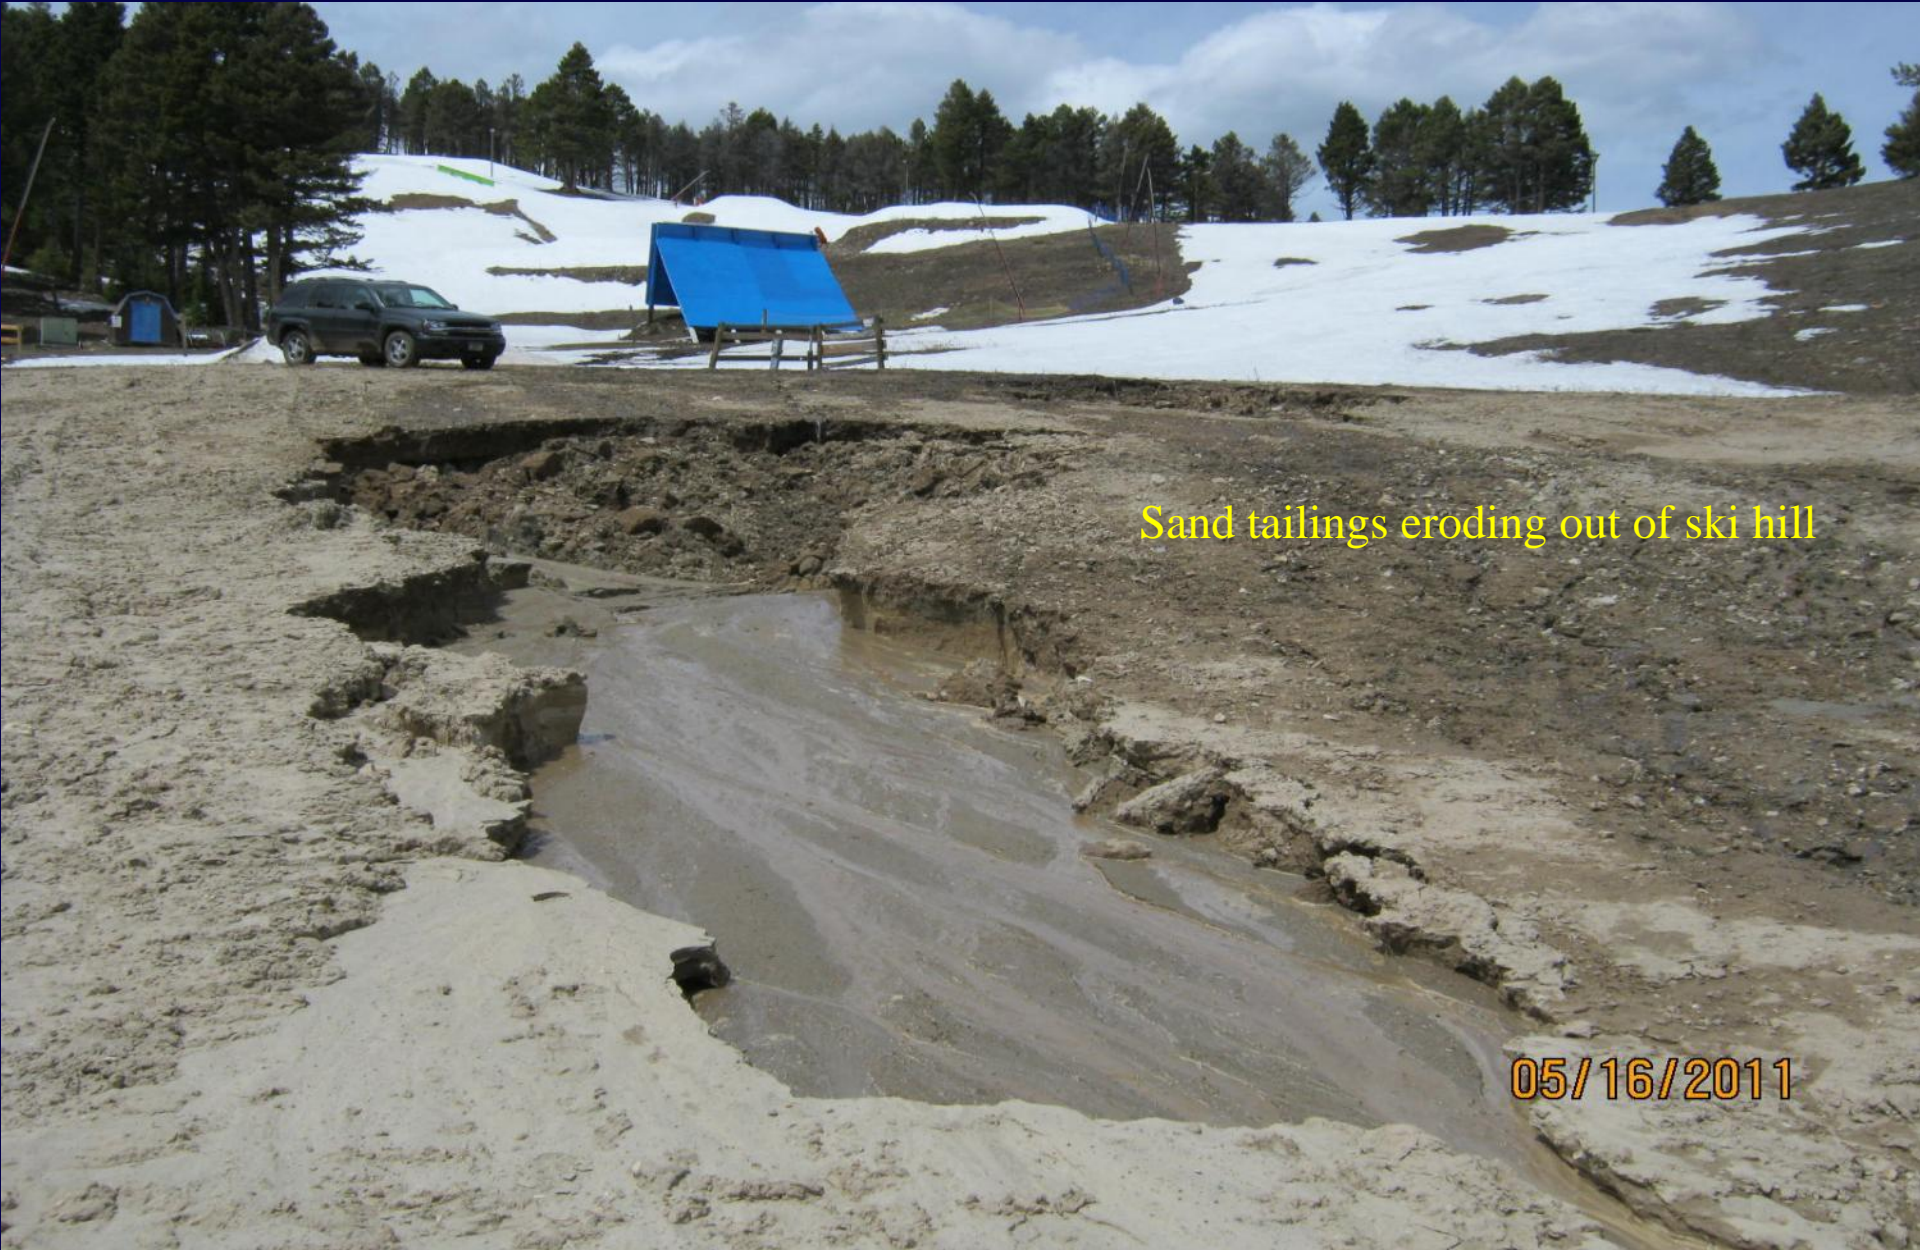
05/16/2011

Sand tailings eroding out of ski hill
